**Review of ROW-2 Well  
Integrity Investigation  
May 2021  
EP202104200659**

**Final Report  
30 June 2021**

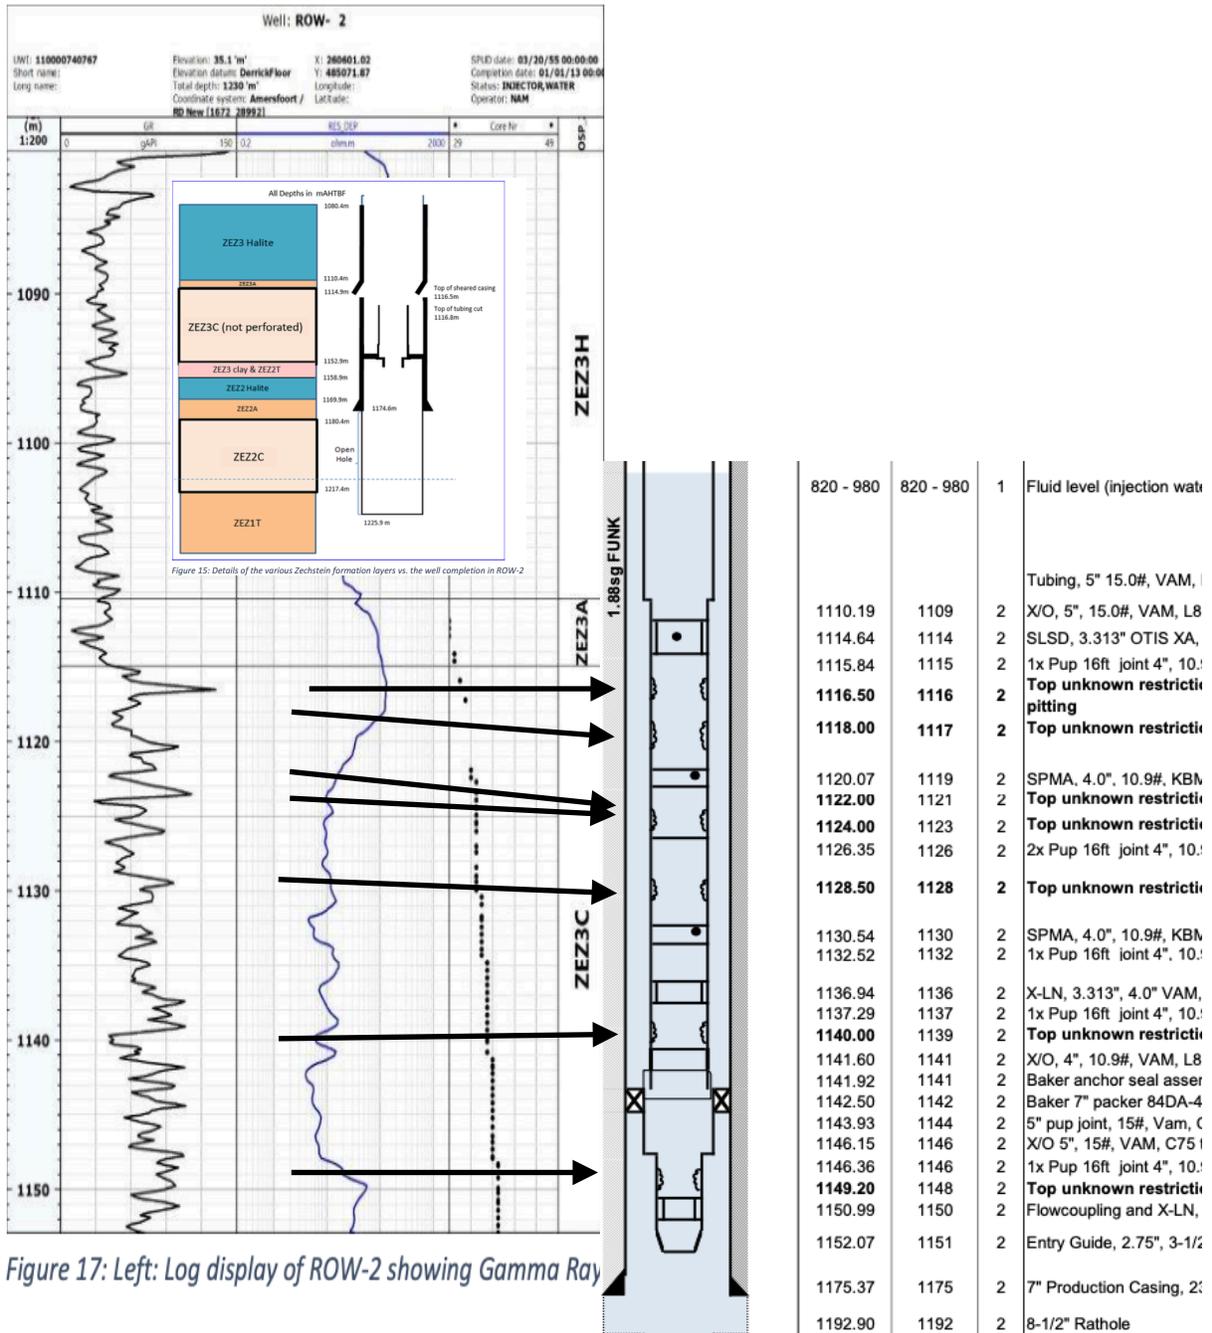
**Appendix IV. - Figure showing locations of tubing deformations detected over the life of the ROW-2 injector**

- Tubing ovalization had been detected at several points opposite the ZEZ3C prior to and following this pressure loss event; locations got progressively shallower as time went on

- Casing shear displacement is inferred to have caused ovalization of injection tubing at 1116 m approximate depth in late 2019, leading to inability to run tools into the well

Figure 17: Left: Log display of ROW-2 showing Gamma Ray
