/ Frisia Zout B.V., Lange Lijnbaan 15, 8861 NW Harlingen, Nederland

Betreft: Eindrapport BAS-4 End of Well Report

## **END of WELL REPORT**

### **BAS 4**

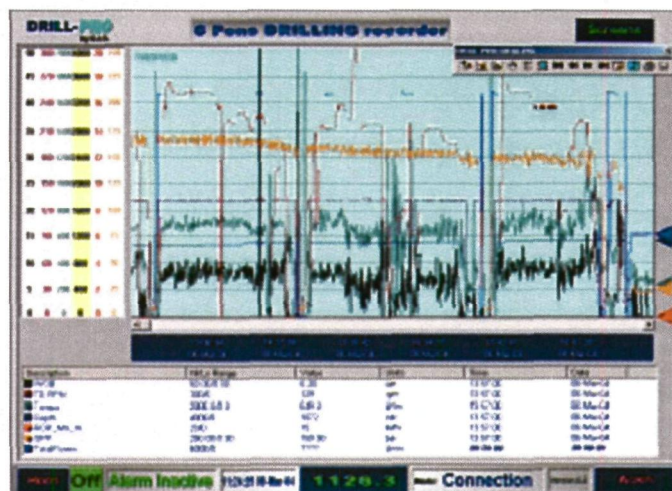
Drilling the lower North Sea (Landen) clay, SPP started to drop slowly and gradually, which wasn't noticed right away. Unfortunately, a remark from the driller who came on shift at 18:00 hours of the day and who pointed out that SPP was some 8 Bars lower than then day before in spite of the fact that well depth had increased by some 150 m which counted for an increase of SPP by some 4 or 5 Bars, was not paid the right attention to. As absolute value of circulating pressure was within the limits set by the hydraulics calculation, drilling was continued until at 1126 m pressure surges were seen, SPP suddenly dropped two times by 10 Bars with bit on bottom and ROP went to zero. At pick – up, SPP again appeared to have lost another ~20 Bars so string was pulled. Top ten centimeters of the fully washed through connection of the lowest 9 ½" drill collar was brought to surface, still firmly made up around the pin of the pony drill collar above with 1 or 2 cm of this pin sticking out. Left in hole was the remainder of the collar and the bit with bitsub.

Fish was recovered by a basket grapple in one run. History and test-certificates of subject drill collar were checked and found to be in order. Equipment was used in Spain and checked by an government recognized testing facility. Further investigation to shed light on the backgrounds of this equipment failure will be carried out.

- 9 ½" drill collar wash-through and fish as result.
- Instability of Landen and Ieper clay, due to extended exposure to water based salt saturated mud, caused by fishing job, resulting from above drill collar wash through.
- Communication still not up to the mark.

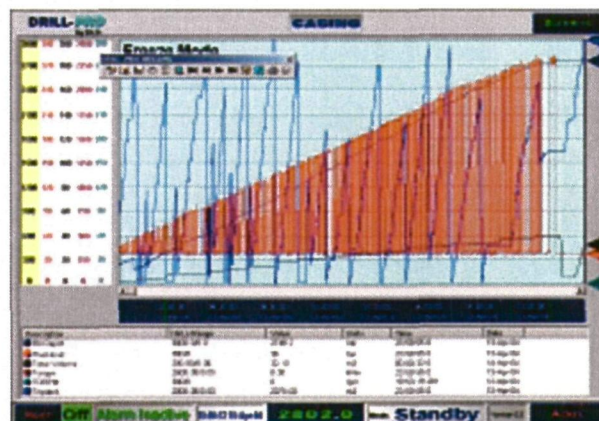
Both the 11 3/4" outer production string and the 7" inner production string were run to planned setting depth without problems. The picture of hook-load increasing with depth versus time as it appears on the BIS screen illustrates very well the proceeding of an undisturbed casing running job in a vertical hole that is in excellent condition. The 11 3/4" diagram is inserted next to this as an example.
