Risk analysis of worldwide salt cavern storage

and its implications for the Dutch cavern storage industry

MSc thesis 01-09-2021
Author Joeri Eising

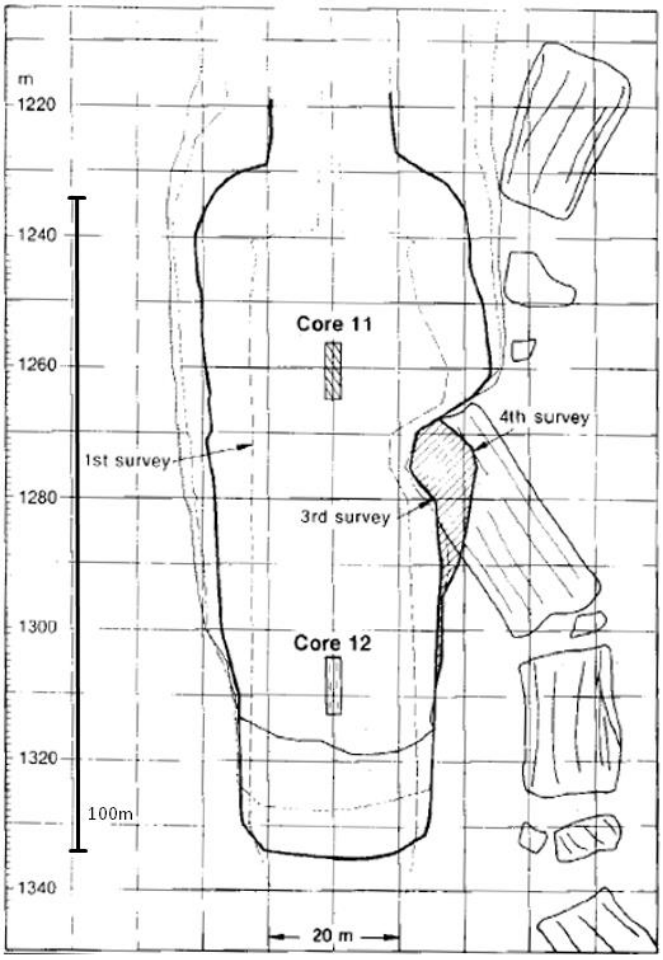
Figure 10 Cavern TO-9 in the Tostrup salt dome, Denmark. From Jacobsen & Nielsen (1992).

Figure 10 shows the shape of cavern TO-9 during several sonar surveys. At the time of

After the fourth survey, step-leaching was used as a mitigating measure, and no more block falls were reported. We assume that step-leaching is the leaching of the upper parts of the cavern, as to not affect the lower regions of the cavern, by heightening the leaching string. It could also mean small volumes are leached before carrying out a sonar survey, rather than leach large volumes at once. This term is not further described in Jacobsen & Nielsen (1992). This way, when the sonar shows an overhanging block, the leaching string depth can be adjusted, and the leaching of the area around the heterogeneity stops. In the case study, the cavern instability incident led to a well integrity loss incident, as the brine string became buried in debris.

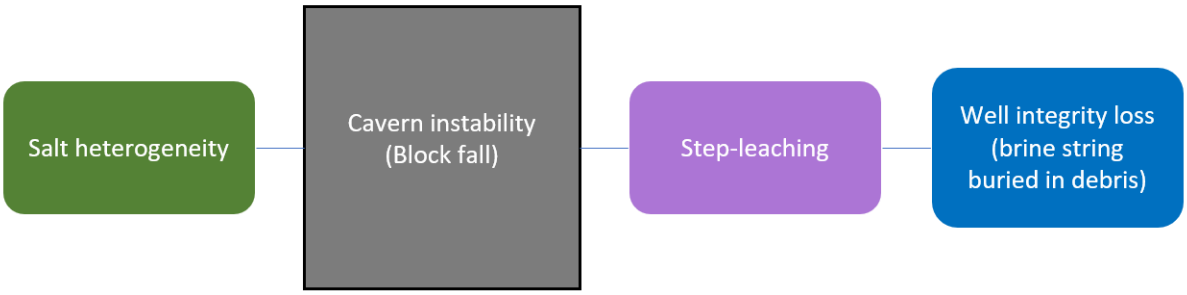
The bow-tie in figure 11, shows the events that took place during the incident. The top event was a block fall. This type of event is characterised by the breaking off of a rock from the wall or roof of a cavern. These blocks can be salt or non-halite inclusions in the salt body. In this case, the block fall was noticed during a sonar survey, as the shape of the cavern changed significantly from the previous survey. The cause of this block fall is interpreted to be salt heterogeneity, a large insoluble block, with very different mechanical properties, was present near the edge of the cavern wall. This piece of upright boudinaged anhydrite-dolomite broke off the wall. Vertical features are difficult to find with seismic sonars, as the seismic shots reflect off of the vertical feature and do not necessarily go back towards the surface. The block fall resulted in the brine string being buried in debris and damaging it.

Figure 11 Bow-tie of the TO-9 cavern instability incident.

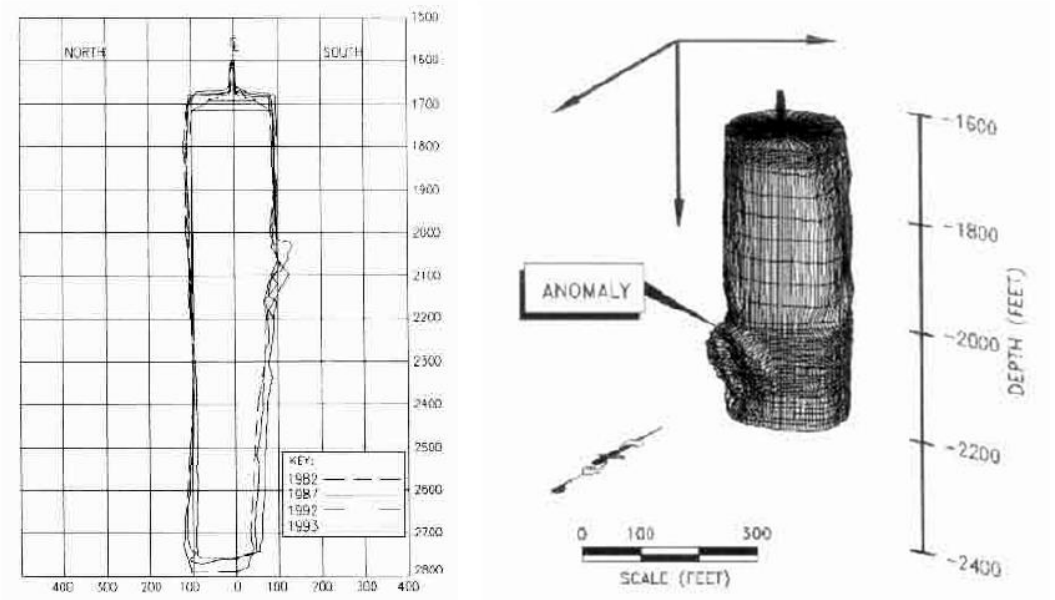
Figure 13 Left: Cavern 14 anomaly growth. Right: sonar survey showing the anomaly bulge. From McCauley et al. (1998).

In 1992 the cavern failed to pass its mechanical integrity test after which oil was removed from the cavern. A leak was detected. A sonar survey showed that there was a bulge in the wall of the cavern, see figure 13 for cavern shape and the bulge. "*This survey better defined the anomaly as a pronounced bulge with a flattened face suggestive of an intersection with a wedge of extraneous material (possibly more soluble than the typical Clovelly domal salt) within the dome*" (McCauley et al. 1998). A pressure survey showed that the leak depth was at the same depth as this anomalous bulge.

An escalating factor was found during a salt proximity survey (surveying the salt wall thickness around the cavern), it showed that the edge of the salt dome was 120m from the cavern wall. The leak path was not through a fracture, but through an inhomogeneity, which had different physical or chemical properties than the Clovelly dome salt. The leak path was likely into a sandstone layer. The effects of this leak path were an irregular shape, the cavern leaching to the caprock and finally, abandonment of the storage cavern. For more information, consult papers written by Brouard (2019); McCauley et al. (1998); Yang et al. (2013) and more information on this storage location can be found in the United States of America section of Appendix 2.

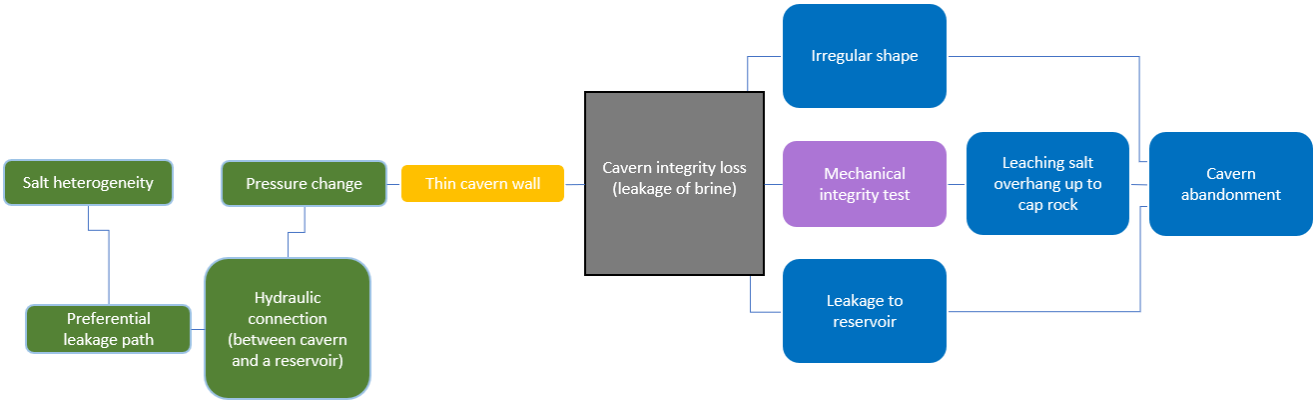
Figure 14 Bow-tie of the Clovelly brine leakage.

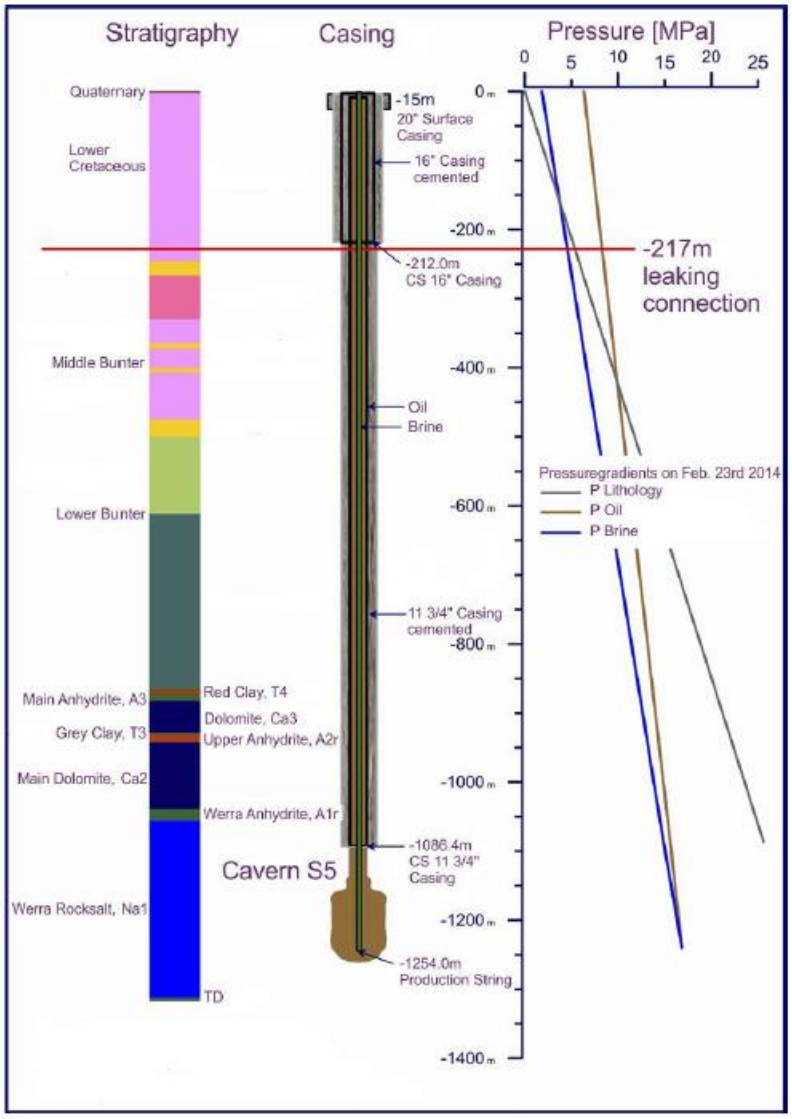
A crude oil storage cavern in Epe, Germany, had well integrity issues in 2014. Cavern S5 experienced a pressure drop of 3.6 bar in February, but no leakage was found after inspection. On April 12th an oil spill was found in a nearby meadow, suggesting a leakage. The bow-tie on the following page (Figure 17) shows the different steps of this incident.

The cause of the damage to the (single barrier) well was movement of the rock mass surrounding the cavern. This induced movement of the rock mass up to the leakage depth of the well. The location of the leak was found using pressure tests and a casing inspection. Casing damage was found at a depth of 217m (Figure 16), just below the double casing/single casing border, a weak point of the well. The cause of the leakage was a pressure difference between the crude oil and the surrounding lithology, the wellhead pressure of the oil was 8.1 MPa, while the capillary entrance of the surrounding material was 4.7 MPa. This allowed the crude oil to reopen fractures and shear zones and flow into them. Over the course of about a month the oil reached the surface, forming an oil spill.

Figure 16 Stratigraphy and pressure of cavern S5 in Epe, Germany. From Hengst (2014).

To reduce pollution, mitigation measures were taken immediately after locating the oil spill. They consisted of lowering the cavern pressure to a wellhead pressure of 2.5 MPa, allowing for back flow of the oil remaining in the fractures. This low pressure allowed the fractures to seal

Going forward, storage in salt caverns in Germany require a double barrier installation for all wells. More information on this case can be found in Hengst (2014), as well as Réveillère et al. (2017) and references therein. More information on the storage location can be found in the Germany section of Appendix 2.

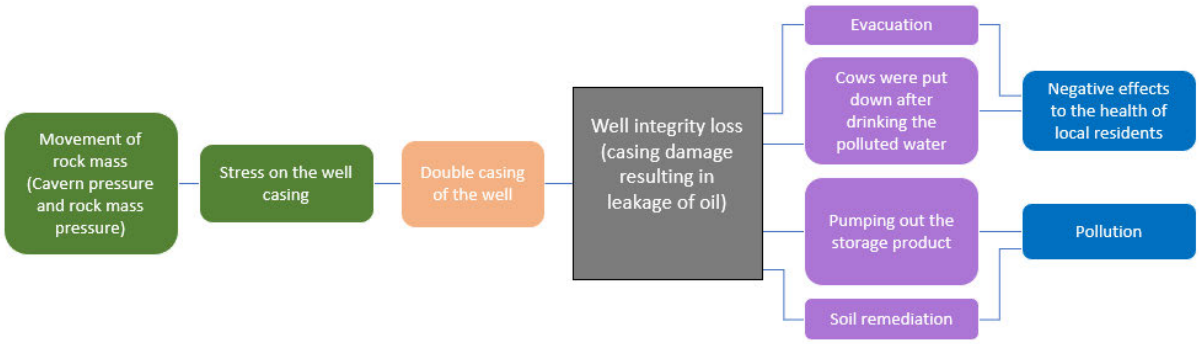
Figure 17 Bow-tie of Epe crude oil spill incident in cavern S5.

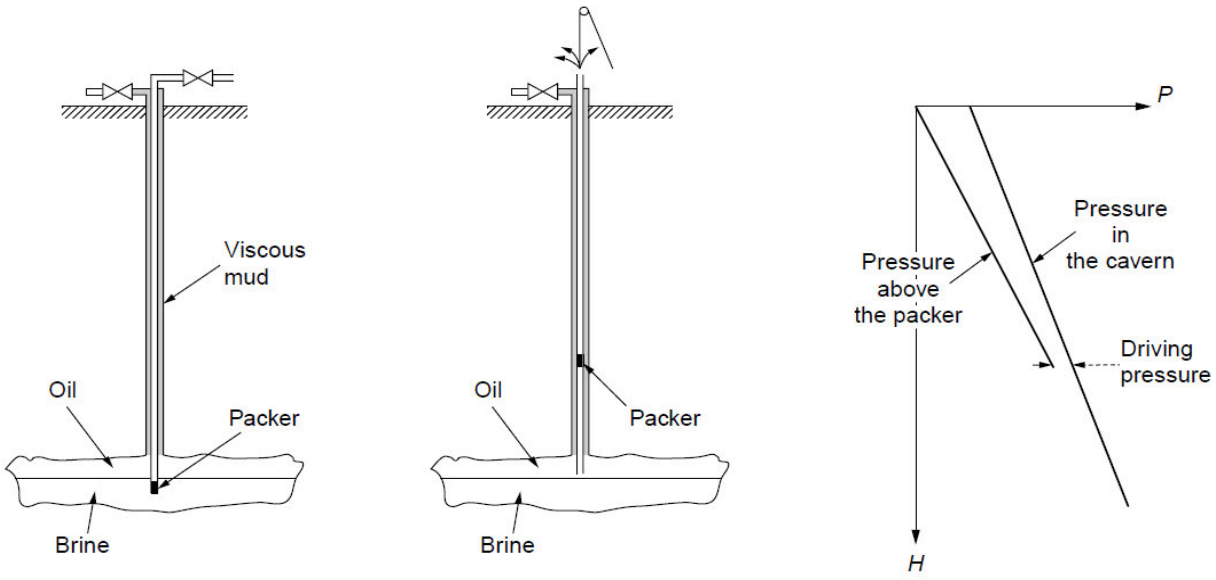
Bérest & Brouard (2003) note that another precaution could have been taken; which is releasing the wellhead pressure on the oil to zero. This would make the chance of a blow-out zero. More information on this case can be found in papers written by Bérest & Brouard (2003); Réveillère et al. (2017); Yang et al. (2013) and more information on this storage location can be found in the United States of America section of Appendix 2.

Figure 19 Schematic of the West Hackberry blow out. Showing the rise of the inflatable packer on the left and middle figure. The figure on the right shows the increasing pressure differential between the pressure above the packer and the pressure in the cavern. From Bérest & Brouard (2003).

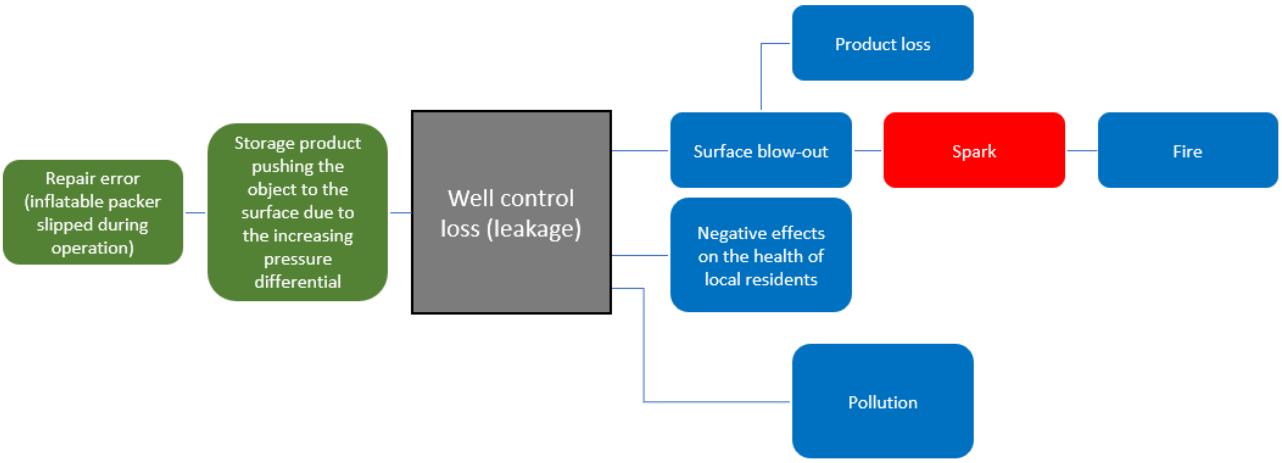
Figure 20 Bow-tie of the West Hackberry well control loss incident.

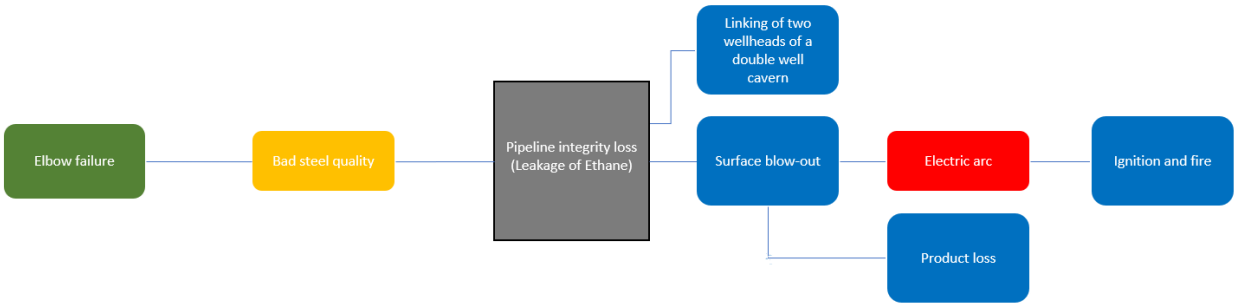
This case study and the bow-tie are based on the pipeline integrity loss of a cavern in Fort Saskatchewan in the province of Alberta, Canada. On the 26th of August, 2001, surface pipelines leaked ethane. "*The cause of this leakage was elbow failure due to a non-metallic inclusion from the internal diameter to external diameter of said elbow, which formed during the forging process*", Réveillère et al. (2017) and references therein. This resulted in the following effects. Two hours after the failure, ethane started leaking and a surface blow-out resulted in loss of the product. This gas plume was ignited by electric arcs, and thus ignited resulting in an explosion and fire. Another effect was that the two wellheads of the caverns double well system were linked. Learnings after the incident resulted in the following two measures; the 2-inch line between the two wells was eliminated and all the natural gas liquid wellhead lines were to be equipped with emergency shutdowns. More information on this storage location can be found in the Canada section of Appendix 2. The case was described by Réveillère et al. (2017), and Yang et al. (2013).

Figure 22 Fort Saskatchewan case study bow-tie.
