## **Addendum Carnallitic Brine Conversion BAS-3**

**September 2012**

Prepared by            WEP, General Project Management and Subsurface Design

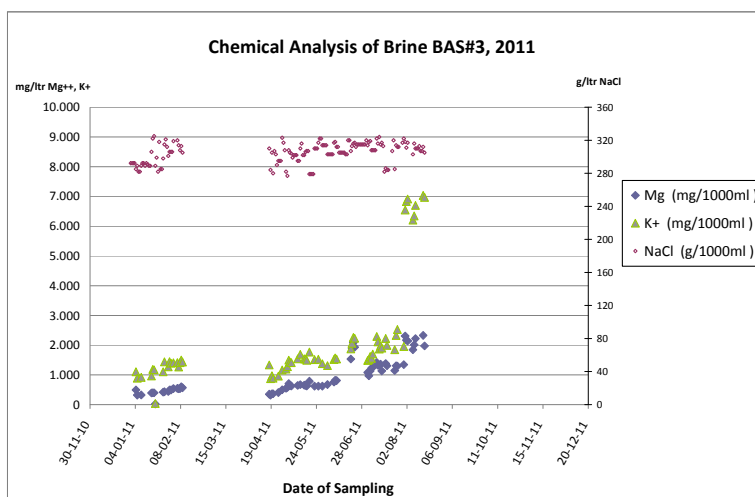
After prolonged and unsuccessful H&P operations to remove a suspected blockage in the 11 3/4" outer leaching string x open hole annulus of the neck area, increased background levels of  $Mg^{++}$  and  $K^{+}$  were observed in June to August 2011, as shown in figure 1. Due to a lack of progress with the H&P operations and the observed changes in brine quality it was decided to stop the operations and to start the abandonment of the cavern. At this stage bent leaching strings prevented access to the cavern.

Figure 1: Development of brine composition during H&P operations

In hindsight the changes in brine quality mid 2011 were the first signs of possible communication with the 51 m thick carnallitic interval from 3906 m ah (2386 m tv) to 3855 m ah (2335 m tv). The brine samples from June 2012 are representative for carnallitic brine resulting from extensive conversion of NaCl brine getting in contact with carnallite.

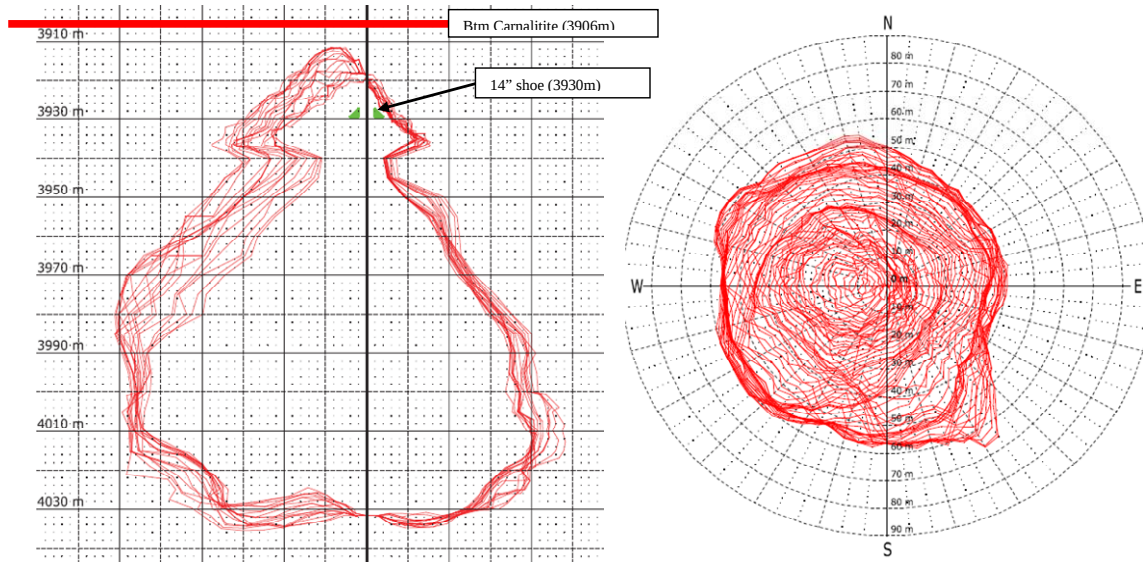
The 11 ¾" string was successfully cut with split shots just inside the 14" last cemented casing and dropped off into the cavern, see figure 4 for a well sketch. The cavern became accessible and an echo survey was made on 6 December 2011. This survey revealed that the cavern had progressed unintentionally to 3912 m ah, circa 6 m below the bottom of the carnallitic interval, as shown in figure 2.

Figure 2: Echo survey results BAS-3 cavern in December 2011

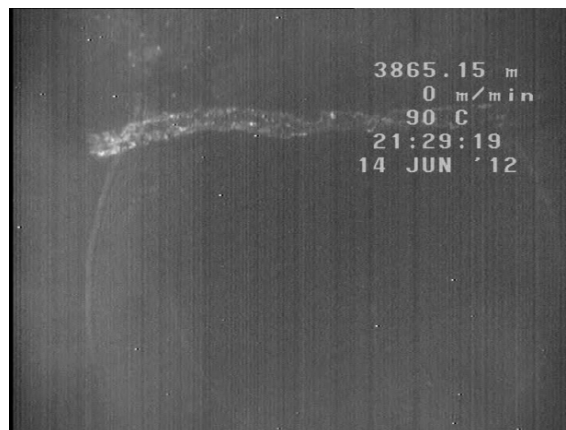
Subsequent attempts to drop off more 11 ¾" casing string by making split shots at several positions in order to provide an adequate interval in the 14" casing for an abandonment plug were unsuccessful and a solid hold-up was encountered at 3908 m, circa 2 m below the bottom of the carnallitic layer. A video run in June 2012 showed a cut connection at 3865 m with a displacement of slightly more than the make-up length of the connection (ca 15 cm).

Figure 3: Video shot of the 11 ¾" connection at 3816 m

The hard hold-up depth at 3908 m may indicate that significant deformation of the casing has taken place that may have been caused by roof instability. The separation at the split connection at 3865 m ah also indicates that there has existed significant tension at the point of the connection and hence significant sticking forces between the 11 ¾" and 14" casings below 3865 m.

While the 11 ¾" x 14" annulus was open the 11 ¾" casing was hanging free in the cavern. The separation at 3865 m cannot be explained by the tension that existed at that time. After the 11 ¾" x 14" annulus became plugged, tension may have been caused by cooling down of the well. However, another cause of tension in the 11 ¾" casing may have been instability of the cavern roof and the roof pulling down on the casing.

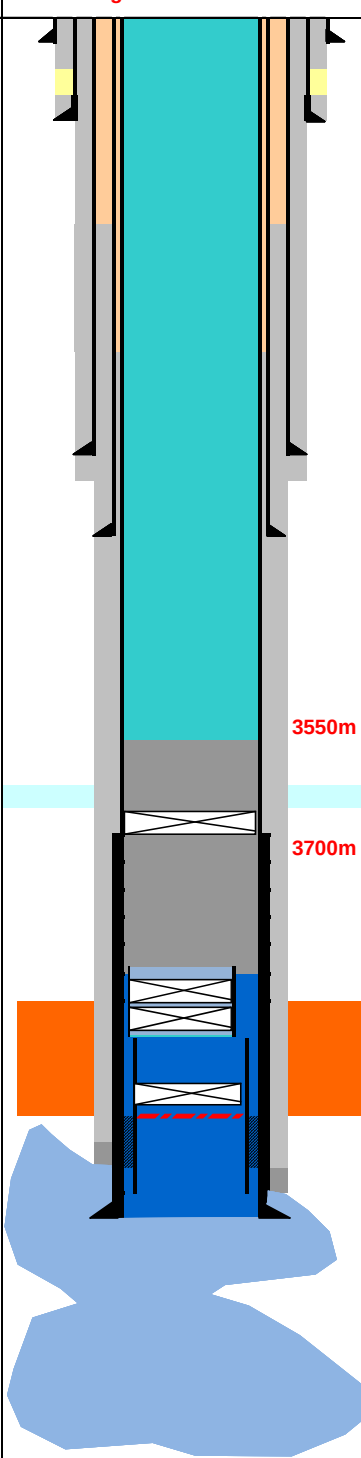
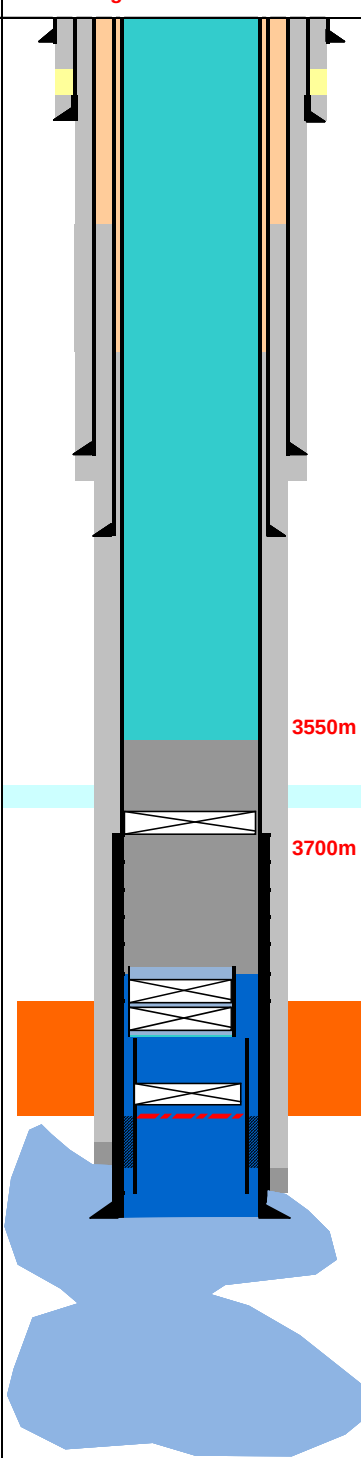
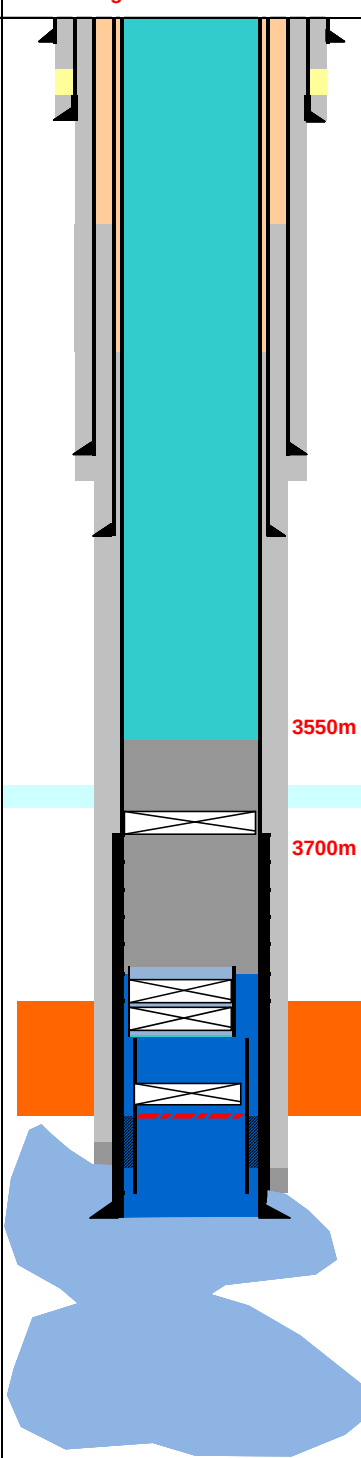
## Attachment 1: BAS-3 Abandonment Sketch

In a separate working program the final abandonment of the BAS-3 current cavern with a HWU is described. With the HWU operation the 11 3/4" leaching string will be pulled out of hole and an abandonment plug will be set in the bottom of the well. See attachment 1 for the planned well situation after the abandonment.

The abandonment program has been adjusted with an extra mechanical barrier and by optimizing the cement placement technique to achieve high quality cement columns across the entire Zechstein section.

The presence of carnallitic brine may cause deterioration of regular cement. Therefore magnesium resistant cement types will be selected.

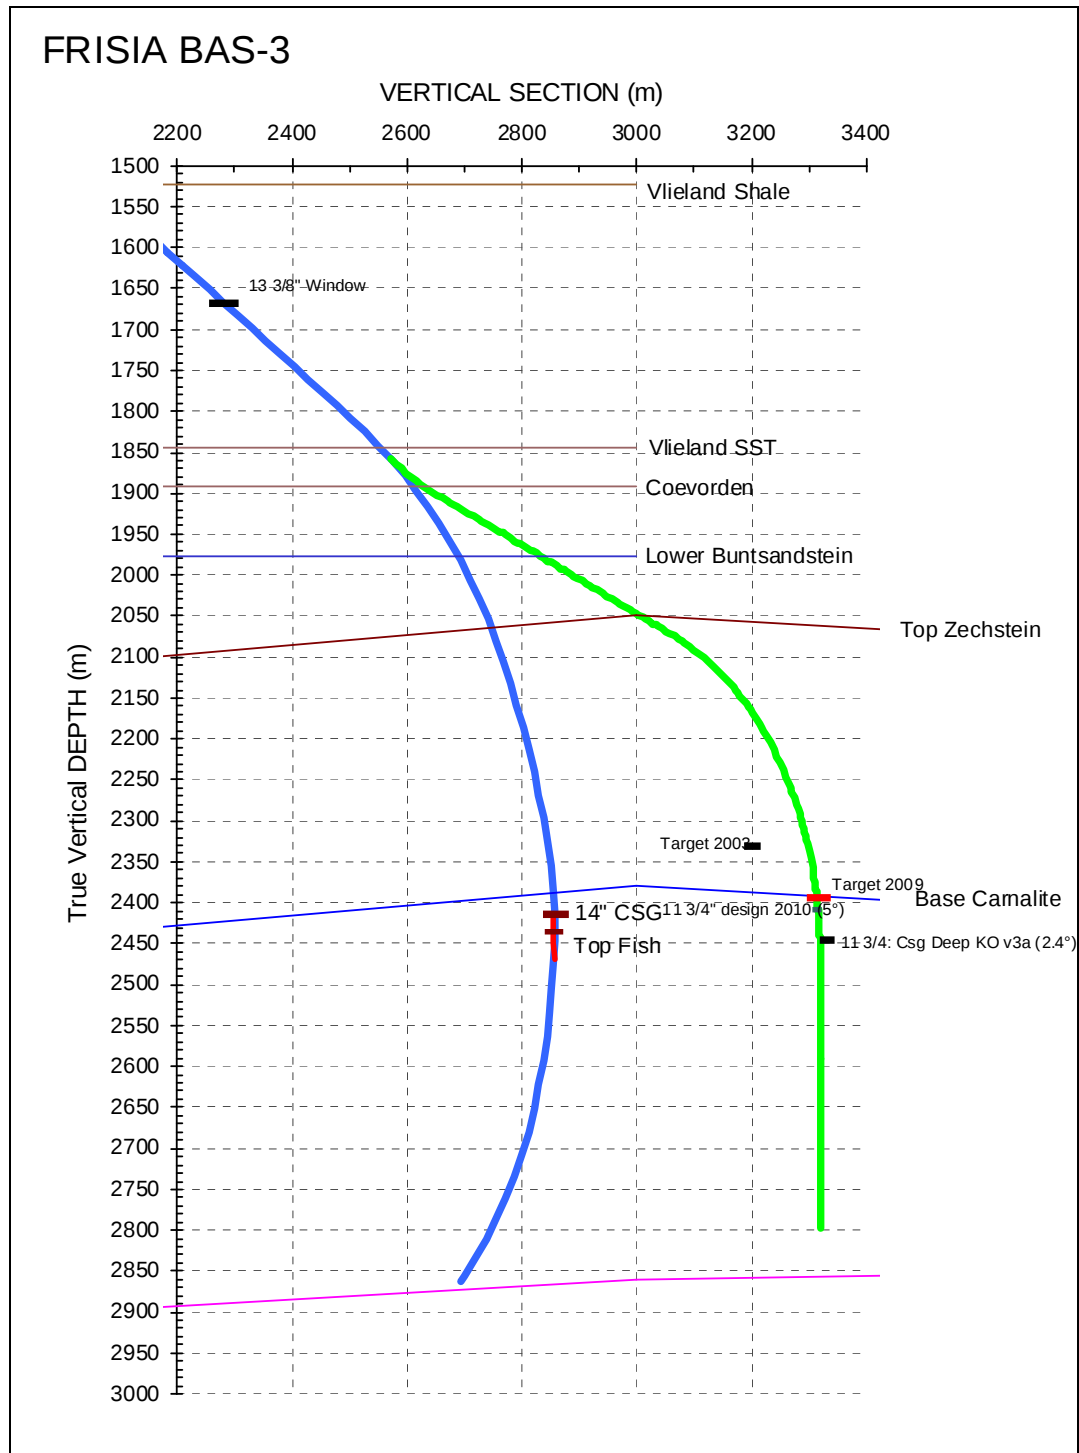
## Attachment 2: BAS-3-O sidetrack trajectory

The remaining open section of the BAS-3 well will be re-used for sidetracking and operating a new cavern BAS-3-O at circa 500 m distance from the abandoned BAS-3 cavern. The planned trajectory of the sidetrack is shown in attachment 2. The bottom of cavern BAS-3-O will be situated at circa 2800 m tv.

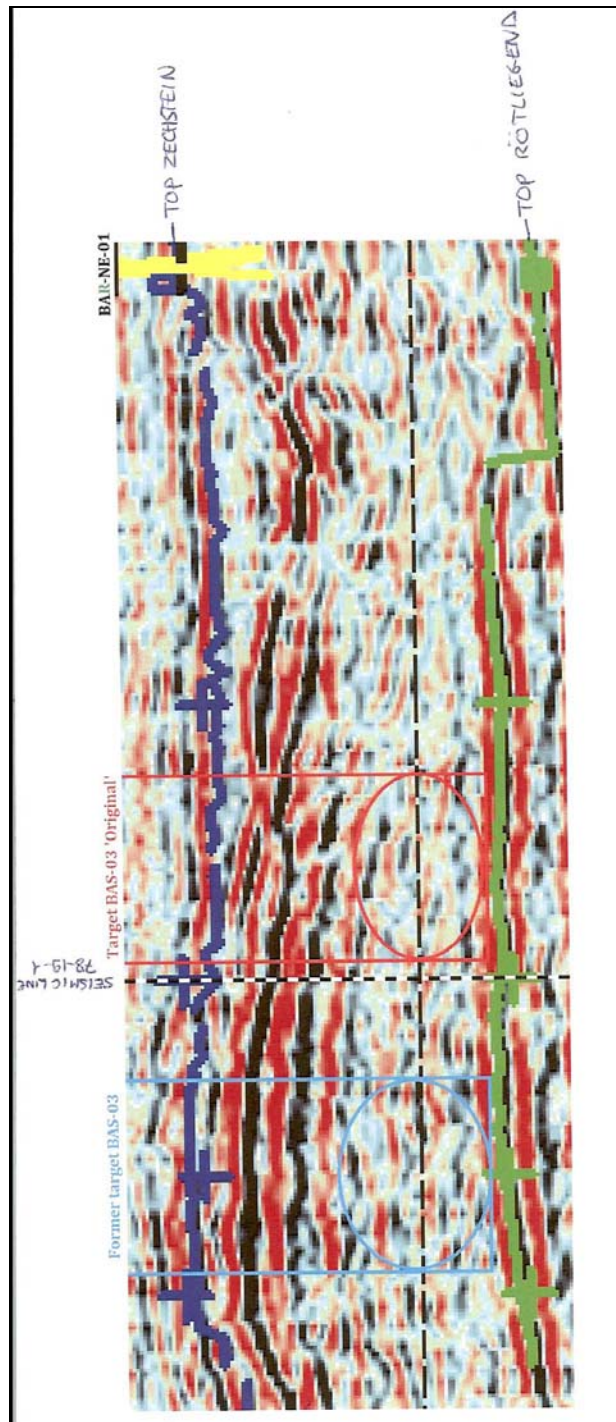
### Attachment 3: Structure map carnallitic interval

It is important that the dissolution front in the carnallitite layer above the abandoned cavern BAS-3 does not progress to the position of the BAS-3-O sidetracked well. In attachment 3 a structure map of the local Zechstein formation is given. Seismic information suggests that there are no dipping trends in the carnallitic interval favoring brine migration to BAS-3-O. Hence, the risk of drilling the sidetrack into lithostatically pressurized free-flowing brine in the carnallitic interval is considered negligible.
