Van: [redacted]@shell.com
Aan: SodM
Cc: [redacted]
Onderwerp: RE: Technische evaluatie Twente putten
Datum: vrijdag 8 januari 2021 14:49:31
Bijlagen: [6 yearly evaluation Twente water injection 2020 kenmerk EP202012203362.pdf](#)

Seismisch risicobeheersplan - Waterinjectie Twente velden

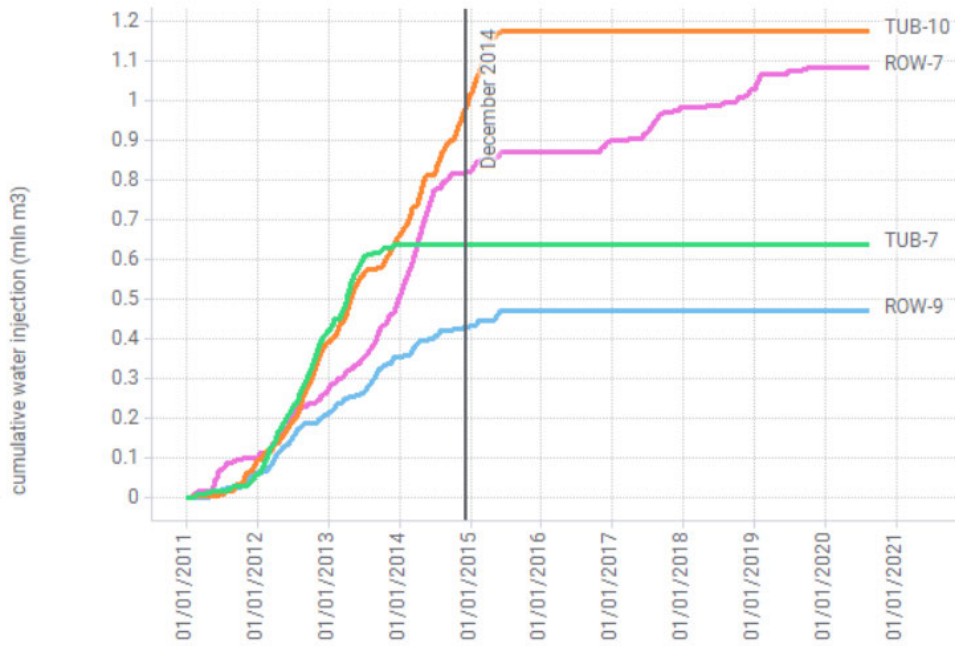
Figure 1-1: Cumulative injection for ROW-7/9 and TUB-7/10. Previous 6-yearly review indicated (December 2014)

It can be observed from the cumulative production in Figure 1-1 that no additional injection took place in to TUB-7 since the January 2015 analysis, Reference [1], and only a couple of months injection into TUB-10 and ROW-9. Injection stopped in June 2015 when it was discovered that the water export pipeline was no longer fit-for-purpose due to integrity issues. As a result, the Schoonebeek field was closed in at 6/6/2015. The water export pipeline was restored in August 2016 after the installation of a smaller 8” diameter flexible composite pipe (FCP) inside the existing 18” water transport pipeline. Due to the smaller inside diameter of the FCP, the water transport capacity to Twente was reduced. Consequently, the full water injection capacity can currently not be utilized. Since the restart, injection is limited to locations ROW-2, ROW-3 and ROW-5, which are connected with corrosion resistant clad pipelines. The injection wells on these locations (wells ROW-2, ROW-4, ROW-5 and ROW-7) have a total potential injection capacity of 5500 m³/d. Well ROW-3 remains available for future water injection. Wells , ROW-9, TUB-7 and TUB-10 are suspended with plugs installed in the wellbore. The TUM wells are listed for permanent decommissioning.

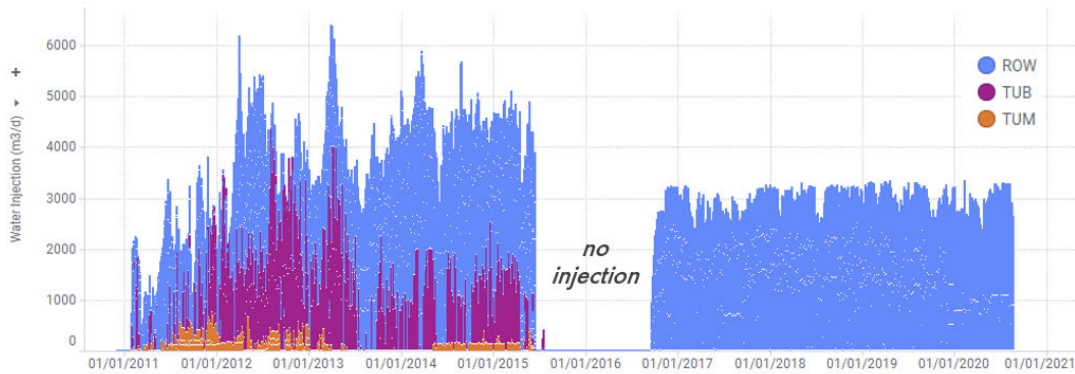
Figure 1-2: Twente water injection timeline

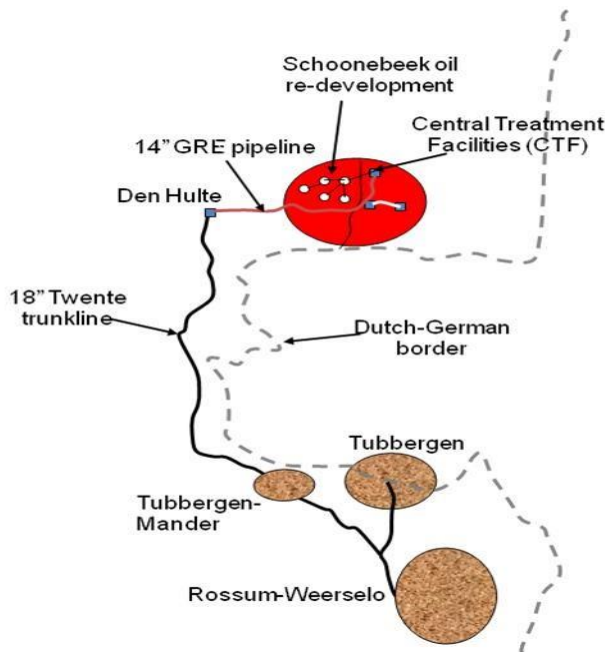
Figure 2-1: Schematic representation of water injection system within Schoonebeek Oilfield production system

As Figure 2 shows, the produced water is transported from the CTF to the De Hulte scraper station via a 17 km, 14” GRE pipeline. This new pipeline has a maximum capacity of 15,500 m³/d and a maximum design pressure of 40 bars. At De Hulte the new 14” GRE pipeline is connected to the 45 km, 18” Twente trunk line, which was previously used to evacuate the sour wet gas from the Twente wells. This trunk line was used to transport the injection water to depleted gas fields in Twente. Due to integrity issues of this pipeline, water injection was stopped in June 2015 and, consequently, oil production and steam injection had to be stopped too. The trunk line was repaired by installing an 8” flexible composite pipe (FCP) inside the existing 18” pipe. The installation was completed in August 2016.

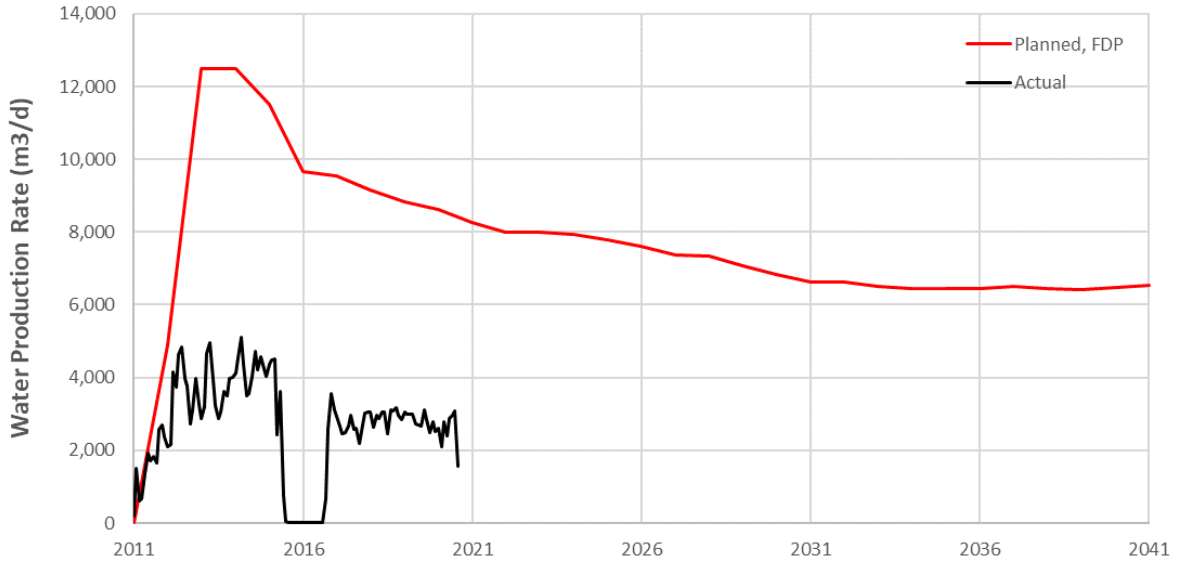
Figure 3-1: Actual water injection rates compared to planned in FDP

In the Schoonebeek FDP it was assumed that during the first 3 years of operations the water injection would be at a plateau rate as high as 12,500 m³/d. In reality, the actual total injection rate was in the order of 4,000-5,000 m³/d, significantly below what was assumed in the FDP (Figure 3-1). The difference between actual and expected injection rates in the FDP is due to lower production rates of Schoonebeek oilfield production wells. Since the water export pipeline repair, the maximum water export capacity is restricted to 3300 m³/d.

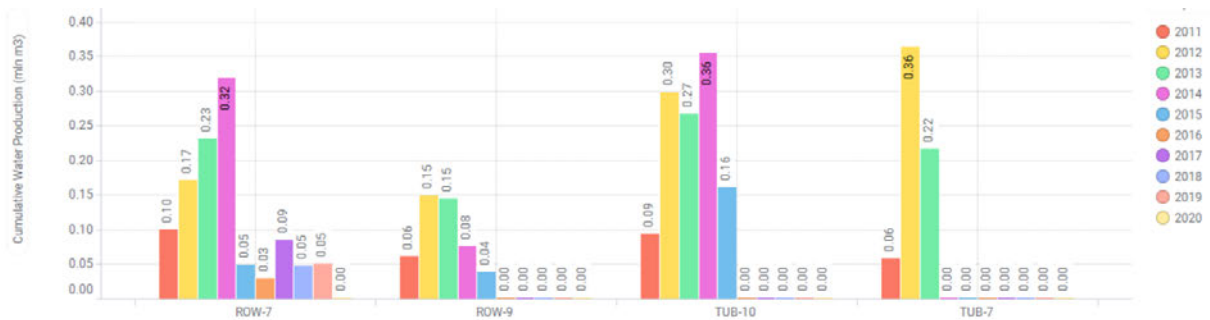
Figure 3-2: Cumulative injective volume per year for the evaluated water injection wells (up to 19/8/2020)

The annual volumes of water injected in the water injection wells from start of injection to date is given in Figure 3-2. Table 3-1 lists the total cumulative water volume that has been injected per location from the start of injection in Q1 2011 until October 2020. Because of the lower than expected water injection rate, the total injected volume at all locations is still much lower than the volumes allowed according to the water injection permit for each location.

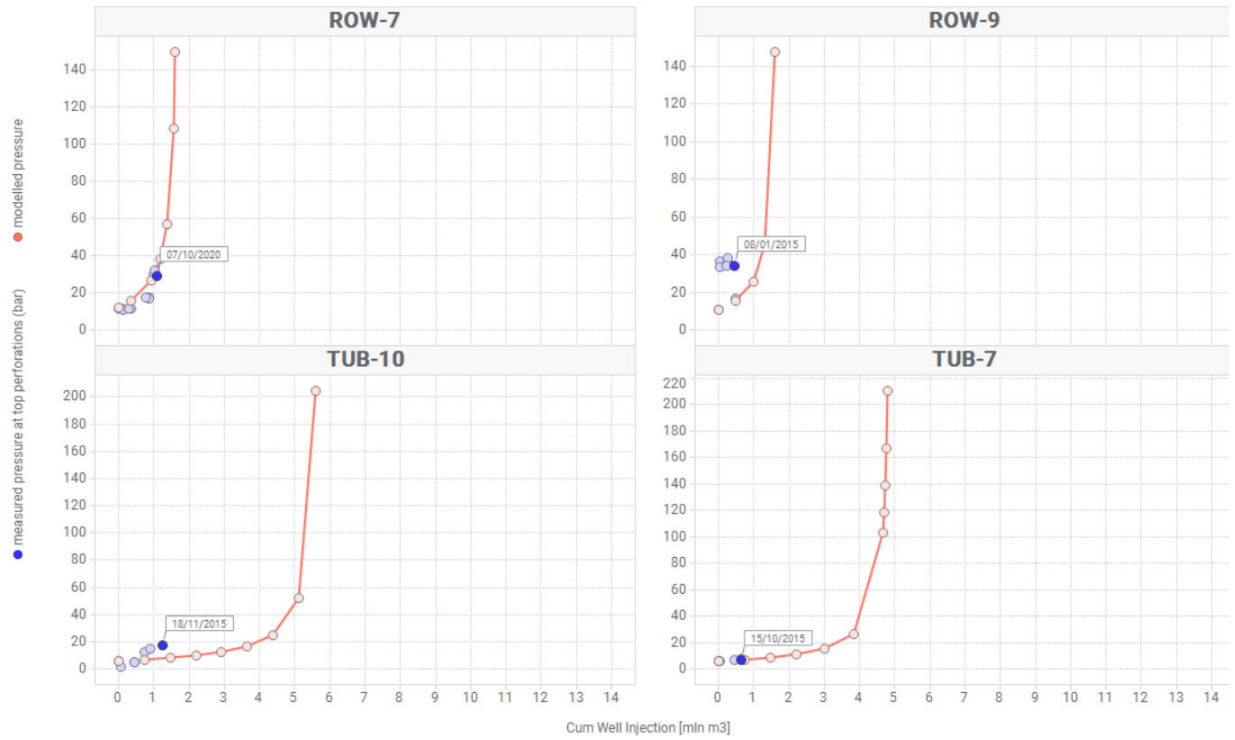
Figure 4-1: Reservoir pressure development during injection. Note: all measured bottomhole pressures have been converted to top reservoir depth of their respective wells.

As described in Reference [8], various dynamic effects are in a complex interplay at the same time: fast transport of water through the fracture network, subsequent entering of water into the matrix rock, thereby compressing the matrix gas, mobility changes of water displacing gas in the matrix due to relative permeability effects, gravity (depending on the height of the injector on the structure, Figure 4-4 and Figure 4-5). The combination of these dynamic effects yielded a higher measured local pressures than the average reservoir pressure for wells ROW-9 and TUB-10, as can be observed from Figure 4-1.

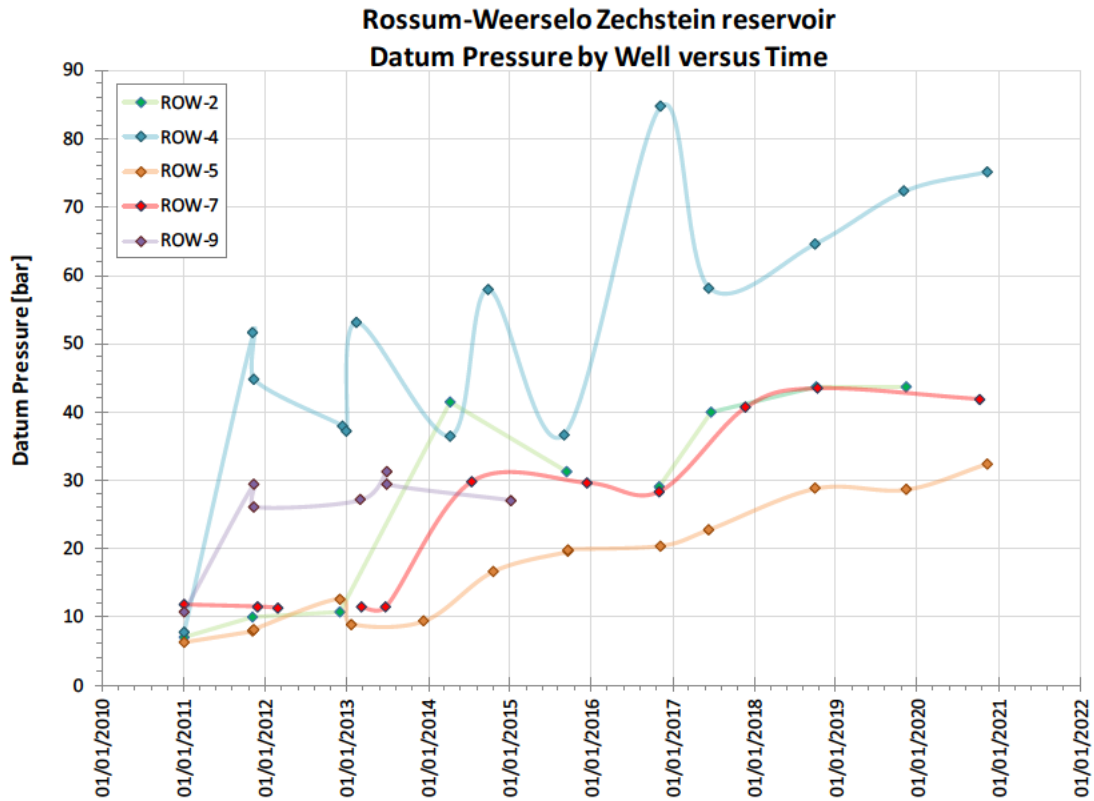
Figure 4-2: Reservoir pressures at datum for the Rossum-Weerselo Zechstein reservoir during the water injection phase as a function of time

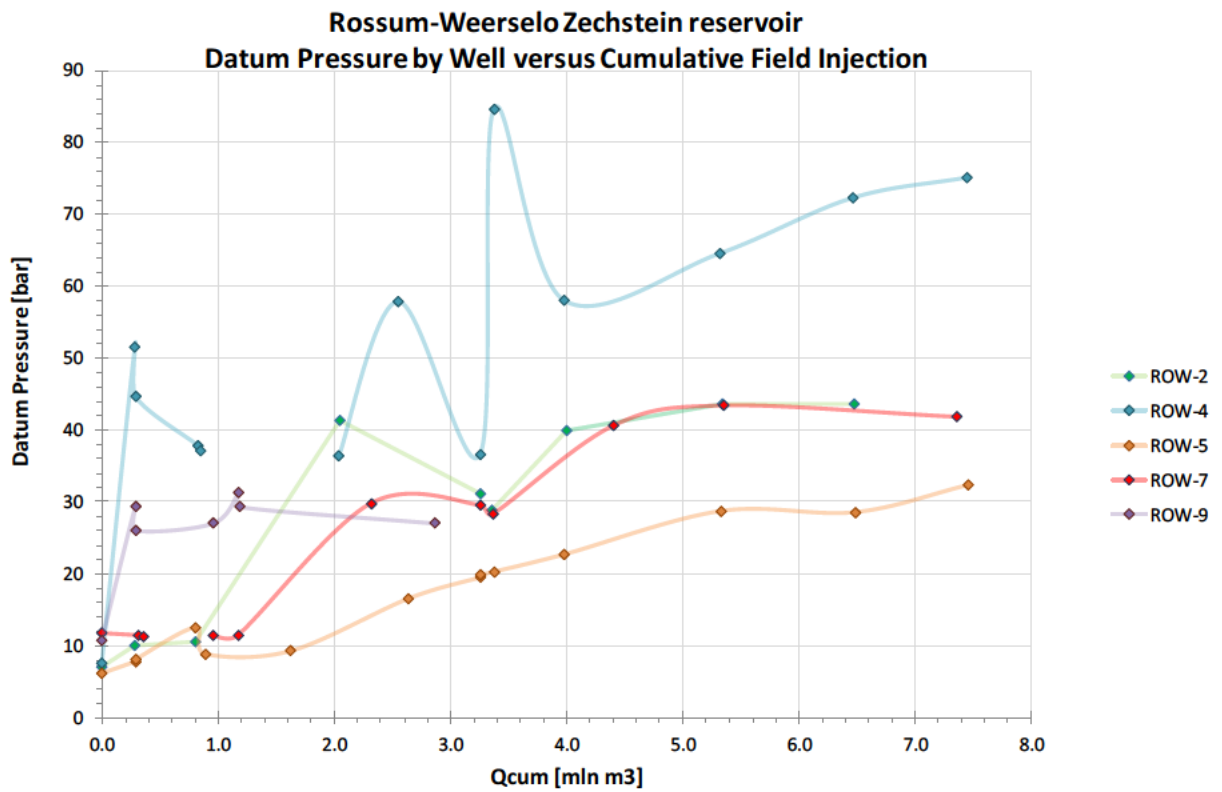
Figure 4-3: Reservoir pressures at datum for the Rossum-Weerselo Zechstein reservoir during the water injection phase as a function of the cumulative reservoir injection volume.

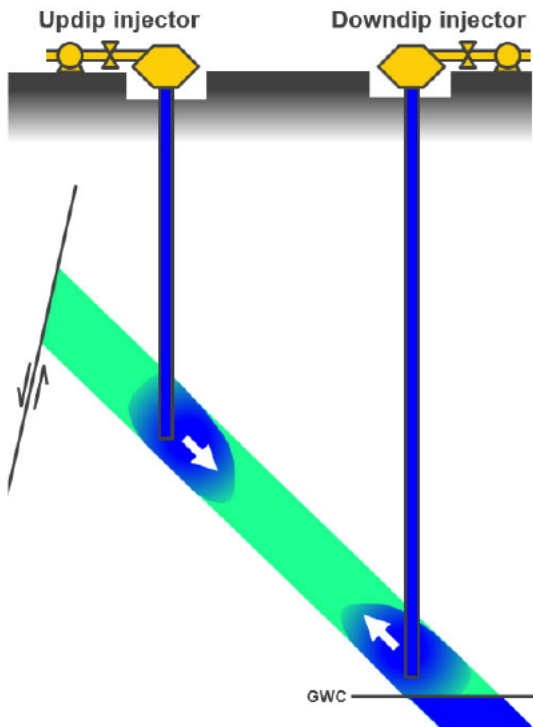
Figure 4-4: Schematic cross-section to illustrate the potential impact of gravity on required injection pressures.

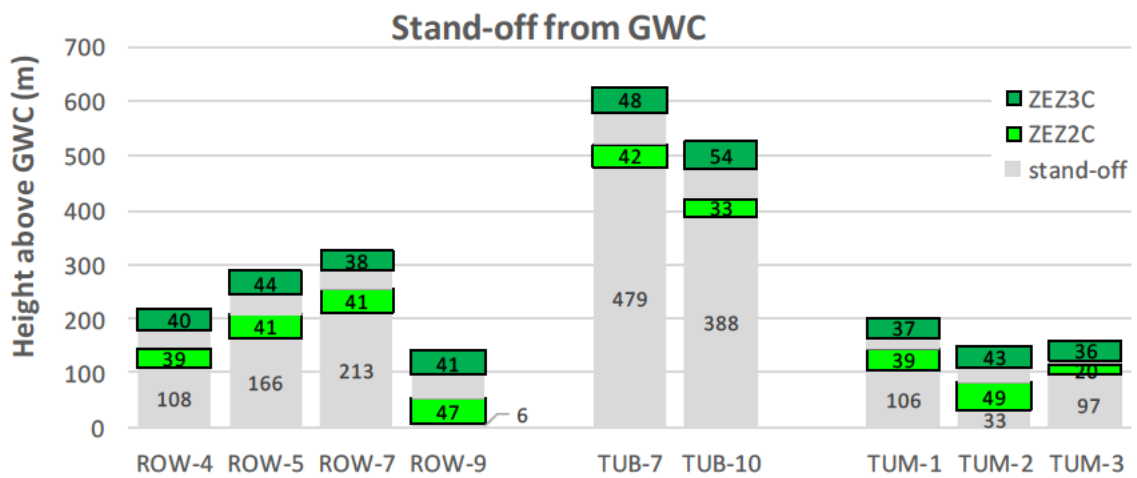
Figure 4-5: Reservoir standoff from the original Gas-Water-Contact

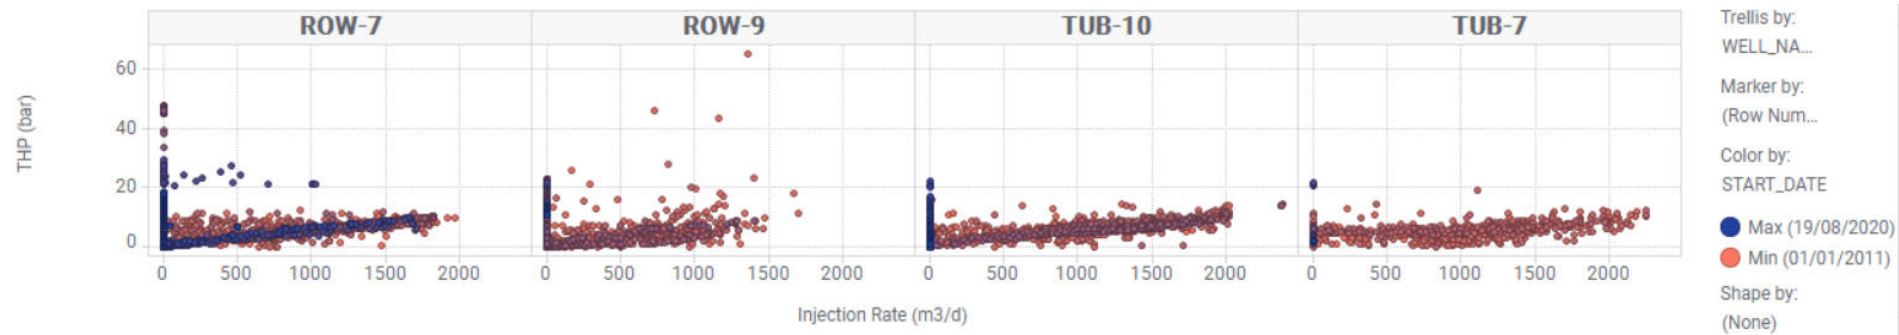
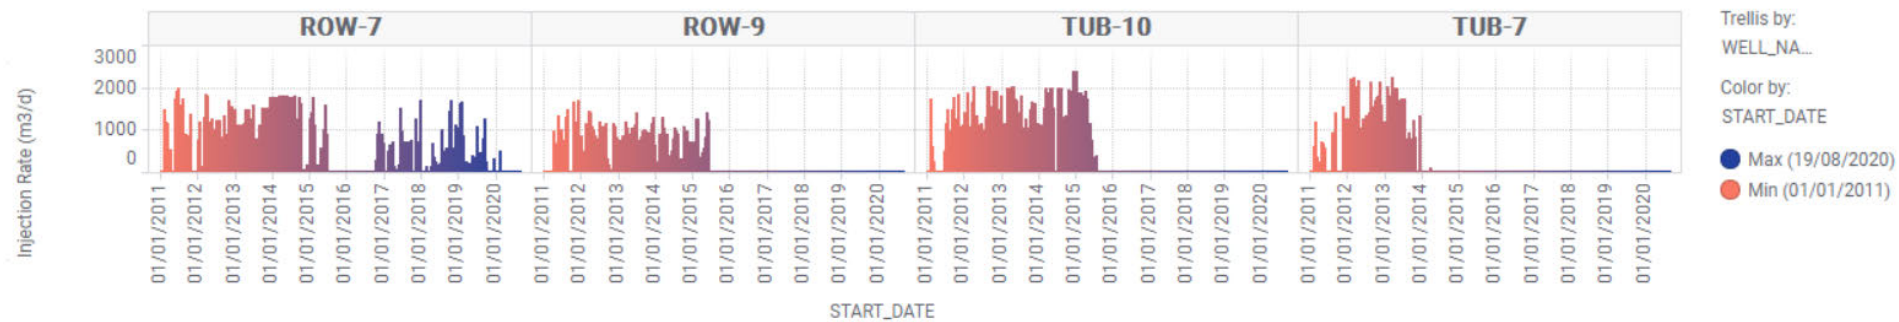
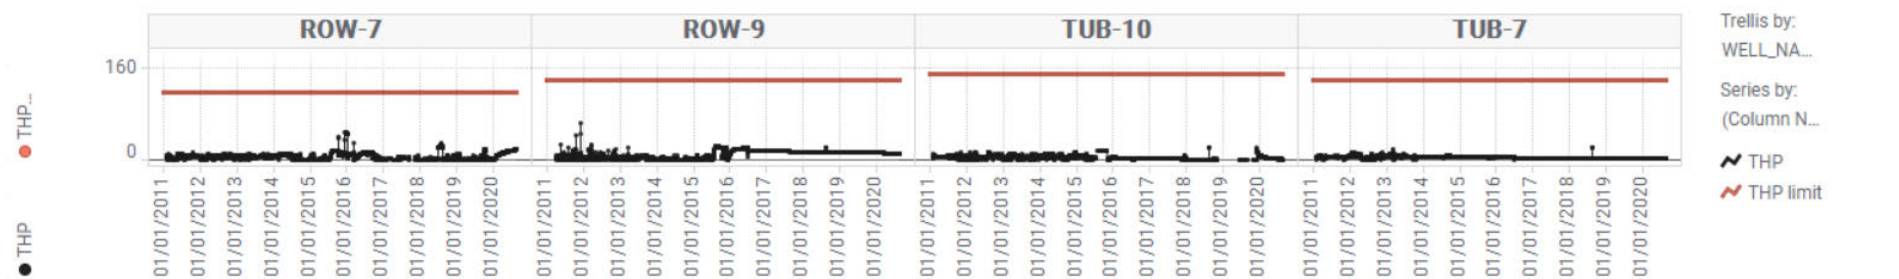
Figure 4-6: Daily tubing head pressure with THP limit, daily injection rates, and cross-plot of THP versus injection rate for wells ROW-7/9 and TUB-7/10, colored by date. Note that the flow rates in the plots are daily averages: when a well was not flowing the full day, the day average rate in the plot is lower than the actual flowing rate when the well was online.

From Figure 4-6 wells ROW-7, ROW-9, TUB-7 and TUB-10 can all be seen to be sub-hydrostatic injectors: the bottomhole flowing pressure is so low that it cannot sustain a full water column up to surface. Water at surface effectively “free-falls” into the well. Consequently, the measured THPi values are only governed by the upstream pressures (showing higher pressures at higher rates due less choking upstream of the THPi measurement).

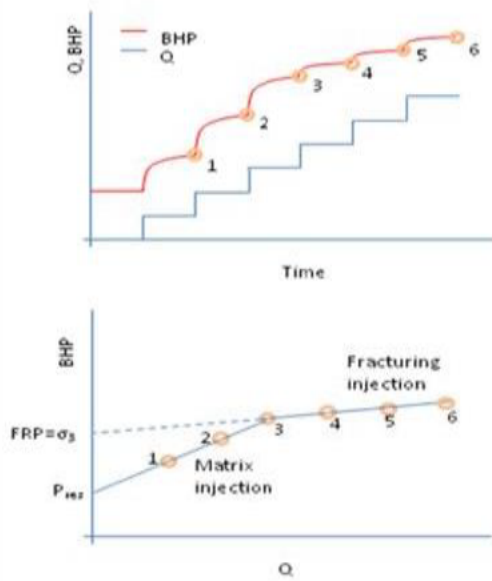
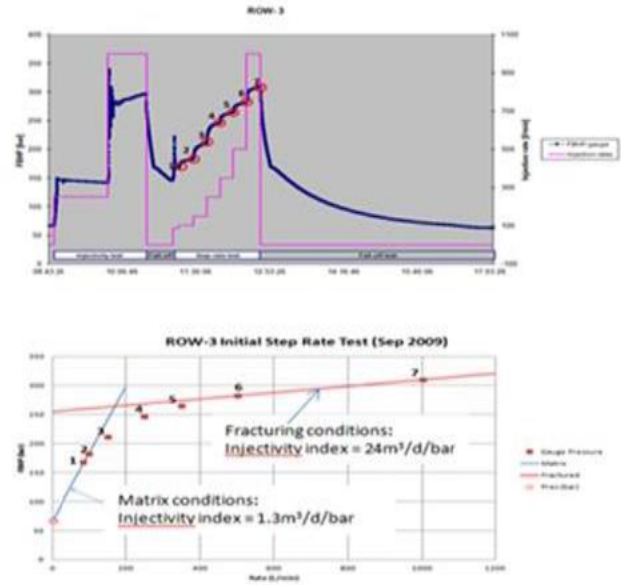
Figure 4-7: Illustration of a step-rate test in a matrix type reservoir. Data from well ROW-3 which connects to the Carboniferous (DC) sandstone reservoir.

To verify that fractures have not propagated into the confining Halite layer, injectivity/step-rate tests (SRT) were carried-out in each water injection well in 2009, and during the first 3 years of injection (2011-2013). Such a test is carried-out with a memory pressure gauge installed in the tailpipe nipple of the completion close to the injection reservoir. Subsequently, injection is started and the injection rate (Q) is increased in steps. During each step the injection pressure is expected to stabilize. Plotting stabilized bottomhole pressure (BHP_i) versus injection rate then gives information on the injectivity. In non-fractured reservoirs it is possible to detect formation breakdown from a change in the slope of the step-rate curve, as illustrated in Figure 4-7.

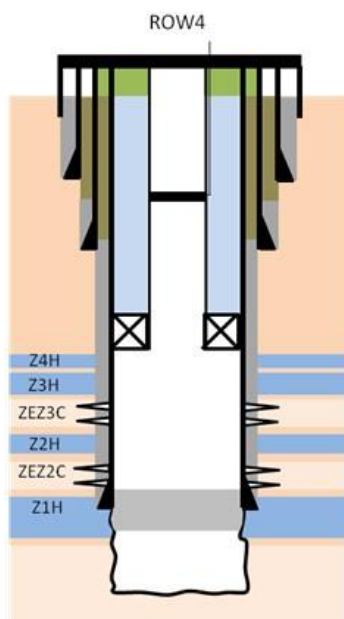
Figure 5-1: Typical water injector well schematic showing Halite sections behind production casing (ZnH represents salt layers, ZEZnC represents carbonate layers where the water is injected into. Between the salt and carbonate layers is a thin Anhydrite layer)

Figure 5-1 shows a typical water injector well schematic where the production packer is set above Halite layers present in the Zechstein formation. To assess the Halite dissolution risk, modelling was performed by Shell P&T in Rijswijk, Reference [10]. The results of the modelling indicate that significant Halite dissolution can only take place near the injection well in case two specific conditions are simultaneously met. Only in case the production casing is leaking and its cement bond has also degraded, there is a path for water to flow directly past the Halite formation potentially leading to Halite dissolution, Reference [11]. If only one of these two conditions is met, the injection water can come into contact with the Halite, but due to lack of flow it cannot dissolve significant amounts of Halite. The confining Halites under and above the target reservoirs in ROW are shielded by the containing Anhydrite layers, which implies that further away from the well, injected water cannot contact the Halite.

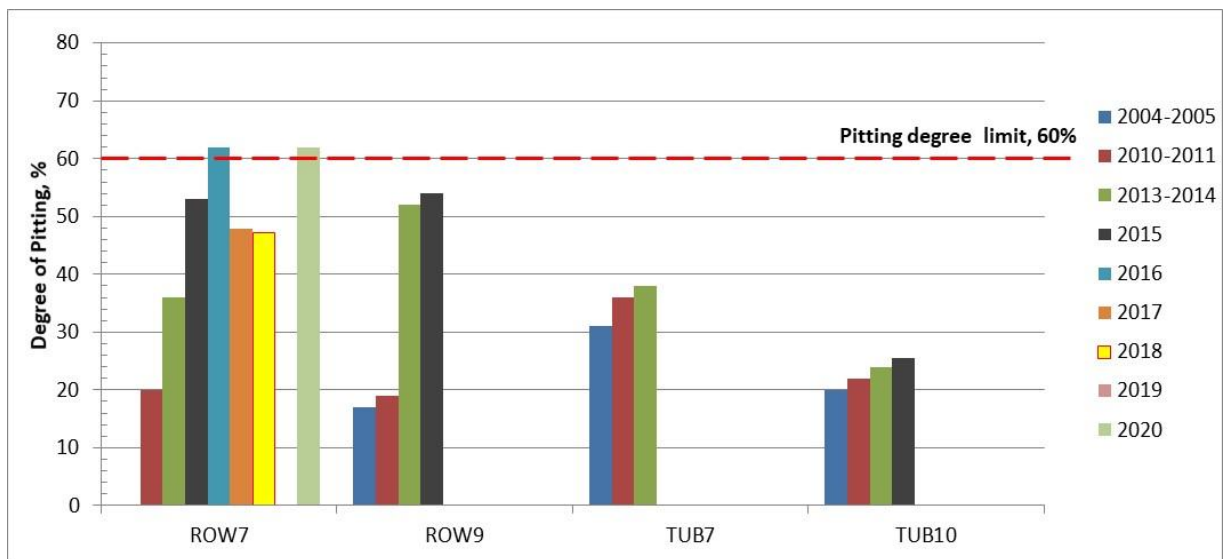
Figure 6-1: Maximum wall penetration for each injection well derived from caliper surveys since start of injection

Notes: (1) ROW-9, TUB-7 and TUB-10 have been suspended since 2015 therefore no recent tubing caliper surveys; (2) Tubing caliper in ROW-7 could not be executed in 2019 due to operational issues.

The maximum wall penetration depth measured in each well since start of injection is presented as degree of pitting in Figure 6-1. The red dashed line indicates the pitting degree limit of 60%, at which NAM's practice is to consider change-out of the tubing, References [12] and [13]. WellCat modelling shows that with 60% corrosion (i.e. assuming worst case scenario that 60% pitting exists uniformly along the entire tubing) the axial and tri-axial loads are approaching the design factors. Figure 6-1 shows that the measured degree of pitting, based on the maximum recorded pitting depth (considered the weakest point in the tubing) for all wells is still below the pitting degree limit of 60%, except for ROW-7. The 2016 survey indicated pitting just above 60%. However, repeat surveys in 2017 and 2018 showed significantly lower maximum wall thickness loss, indicating that the observed pit in 2016 is relatively small in size (given that the 24 arms of the caliper tool did not detect the same pit both in 2017 and 2018). The 2020 survey again indicated the pitting at the same depth to be about 60%. The overall integrity of the ROW-7 tubing condition is still classified as moderate, but the tubing section with the deepest pitting will be considered for pro-active repair.

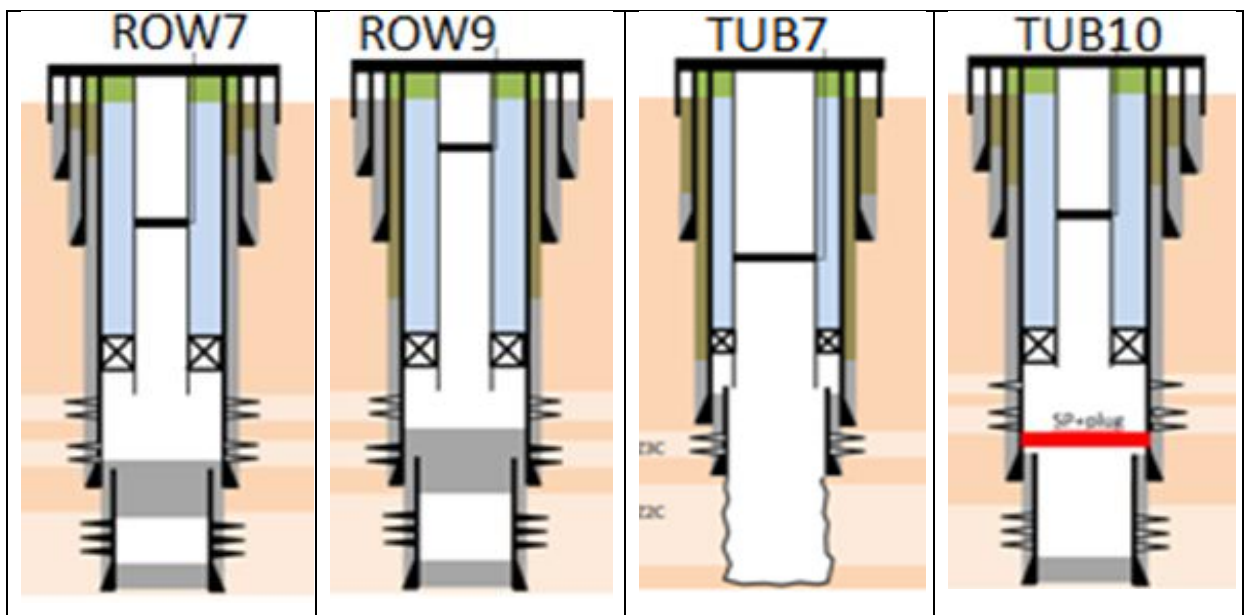
Figure 6-2: Well schematics for the water injection wells

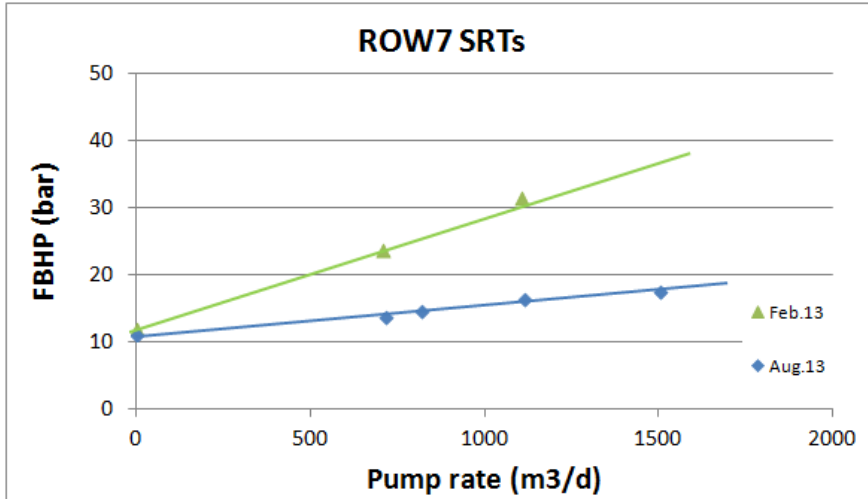
A.1 ROW-7

Note: all measured flowing bottomhole pressures (FBHP) at gauge depth have been recalculated to top reservoir.

An overview of the SRT-plots for each well is given in Appendix A: no trend break in the slope of the step-rate curve is observed. Most SRT-plots show a linear trend, and the wells only require a low BHP_i ($<\sigma_{h,min}$) to inject the planned water volumes. The curve intersects the y-axis at approximately the local near-wellbore pressure.

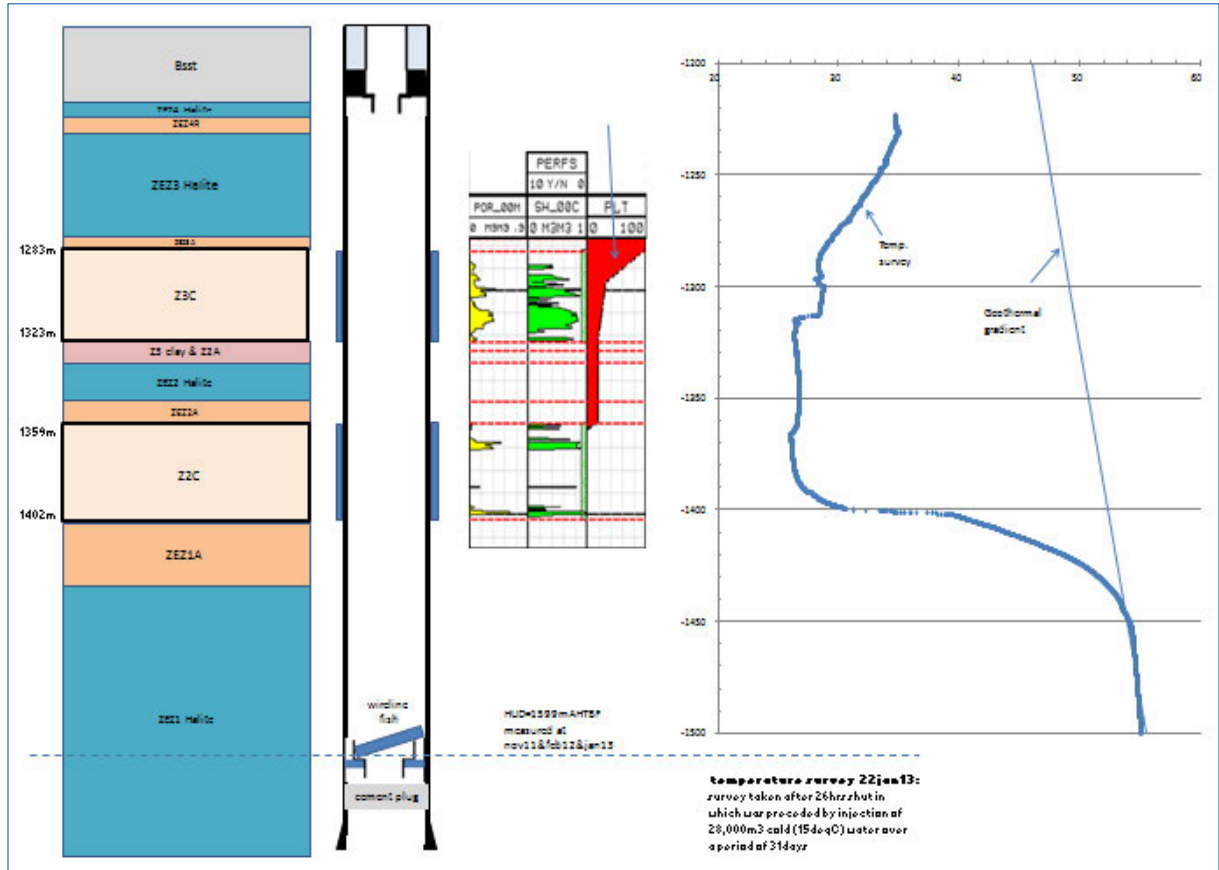
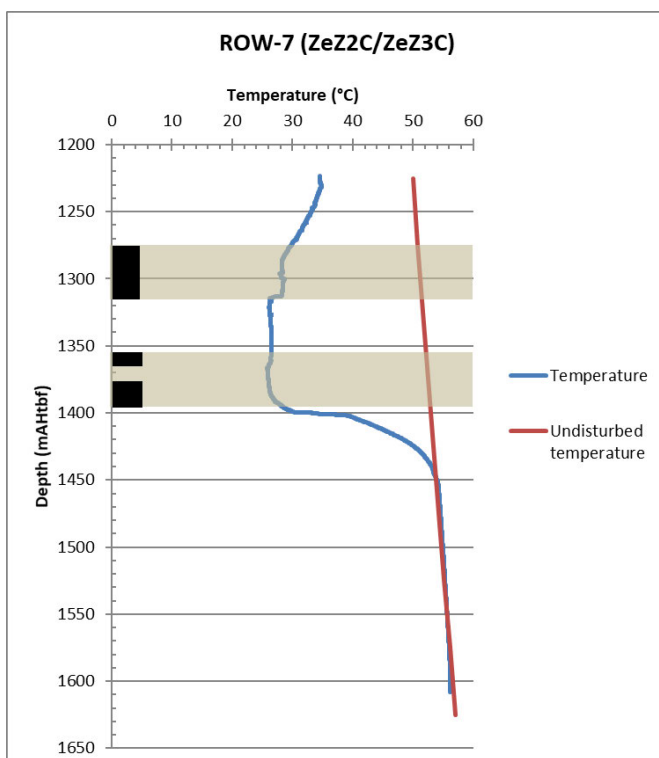
Figure B-1: ROW-7 temperature survey, January 2013

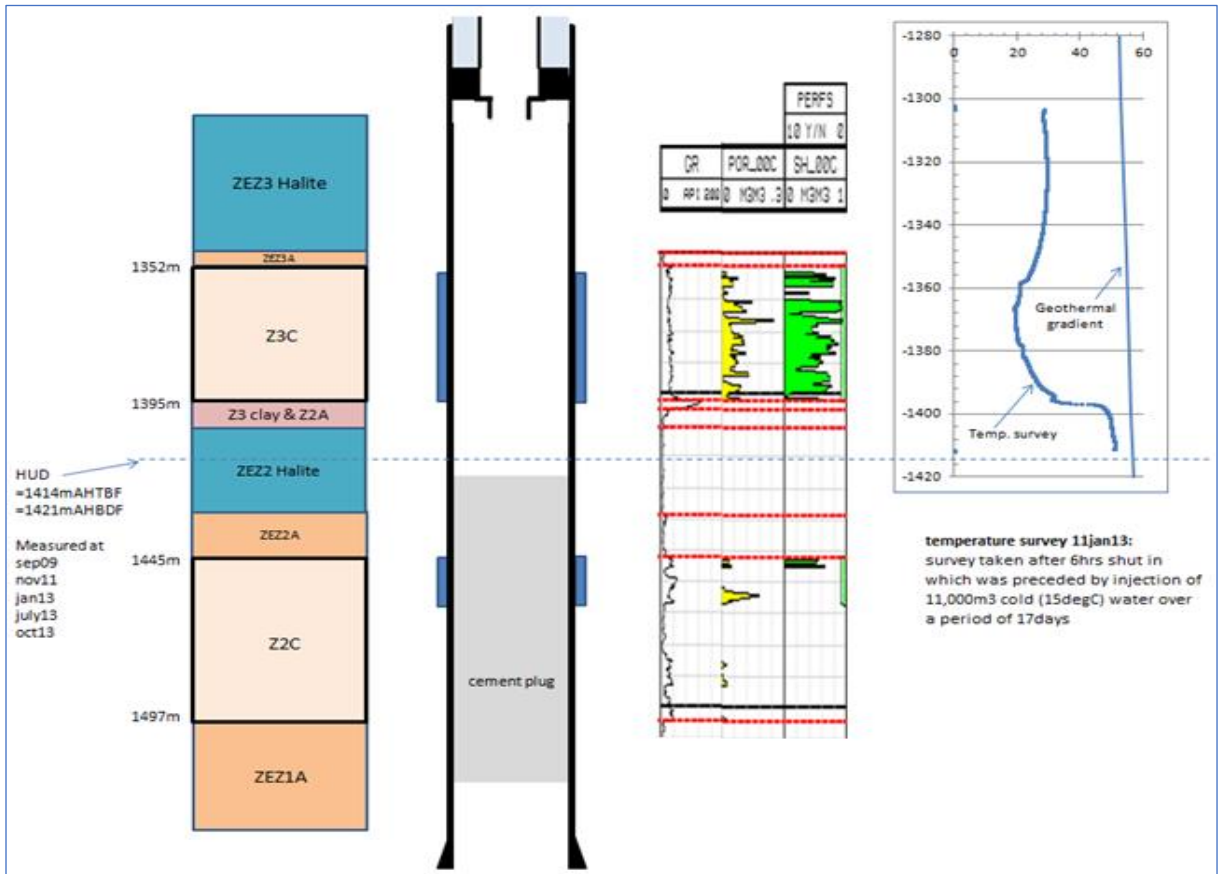
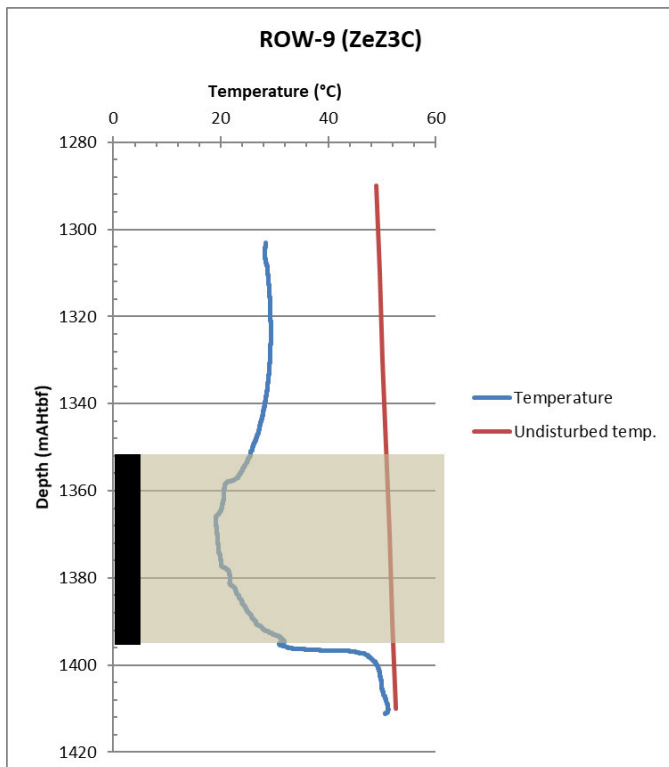
Figure B-2: ROW-9 temperature survey, December 2012

Unambiguous verification of injection into the Carbonate formations only is masked by the varying conditions at which the temperature surveys are executed (i.e. volume injected and shut-in period prior to logging). ROW-9 (Appendix B.2) was only shut-in for 6 hours, which is relatively short to measure a clear warm back from the ZEZ3H overburden. From the temperature surveys in ROW-7 (Appendix B.1) and TUB-10 (Appendix B.4) it is relatively difficult to differentiate injection into Carbonate layers versus that into the Z2H, which is located in between the Z2C and Z3C injection reservoirs. Temperature logs can always show some "smearing" effect. Because of the injection of significant volumes of cold water preceding the temperature survey it is very likely that the ZEZ2H in between the two injection reservoirs as well as the ZEZ3H directly overlying the ZEZ3C reservoir have cooled down as well (conductive cooling), which causes the warm back during the shut-in period to occur much slower. Zooming in on these temperature surveys, shown for TUB-10, however, does show that the warm back of the ZEZ2H has started.

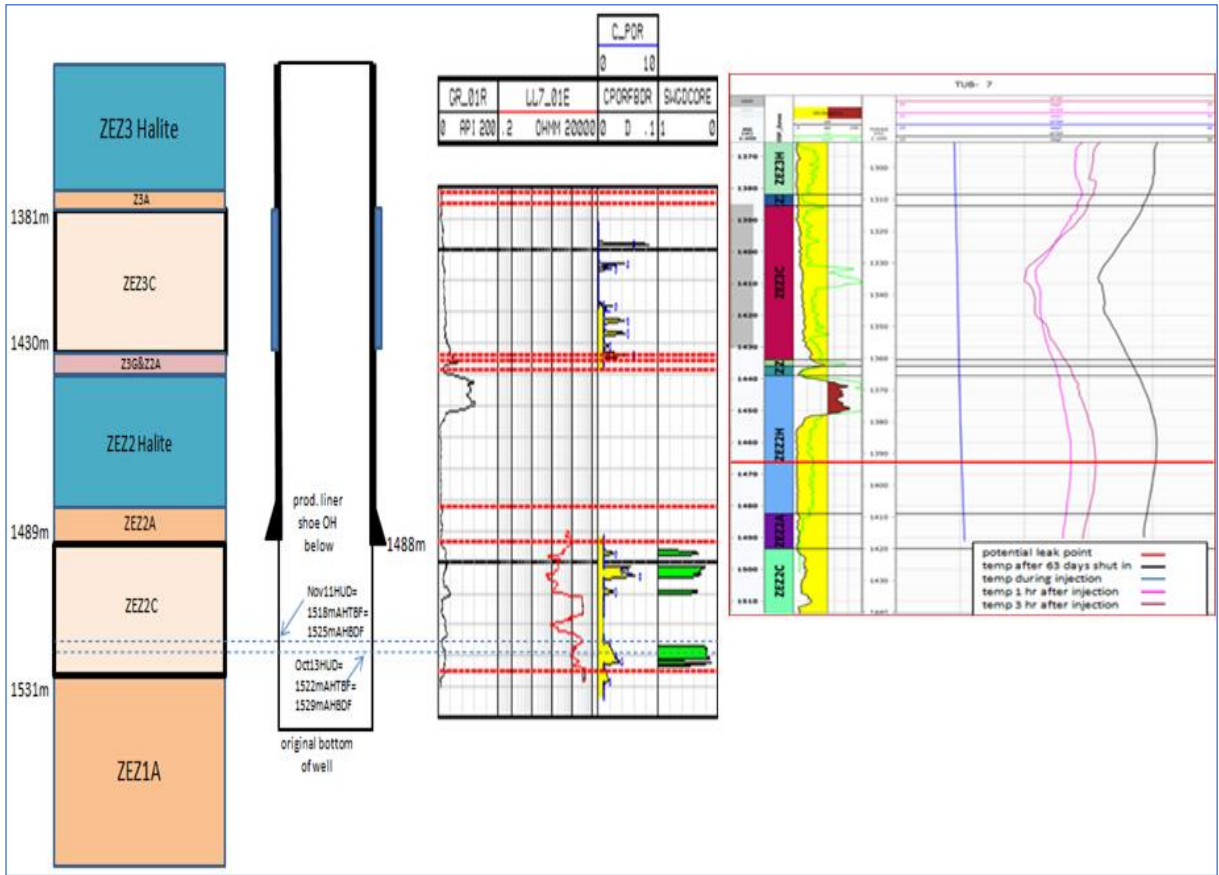
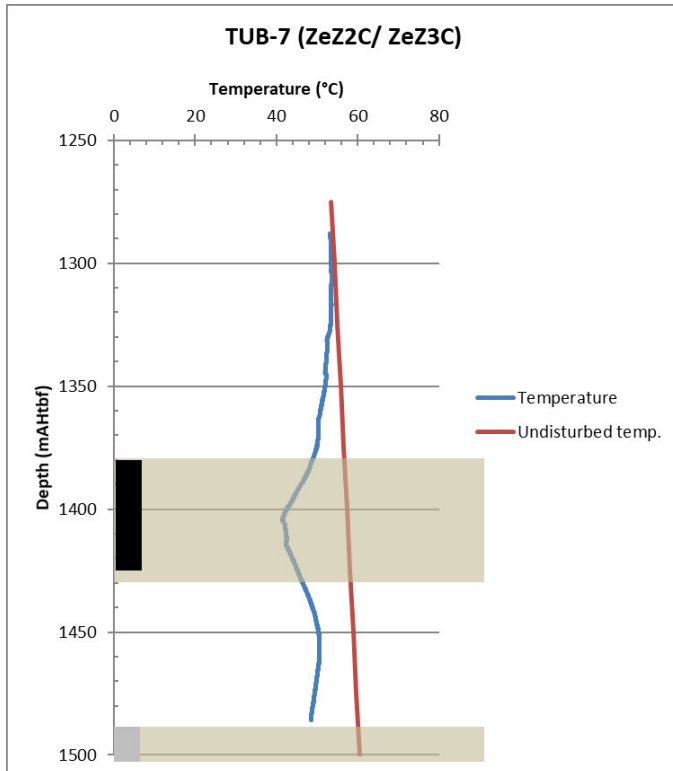
Figure B-3: TUB-7 temperature survey, March 2013

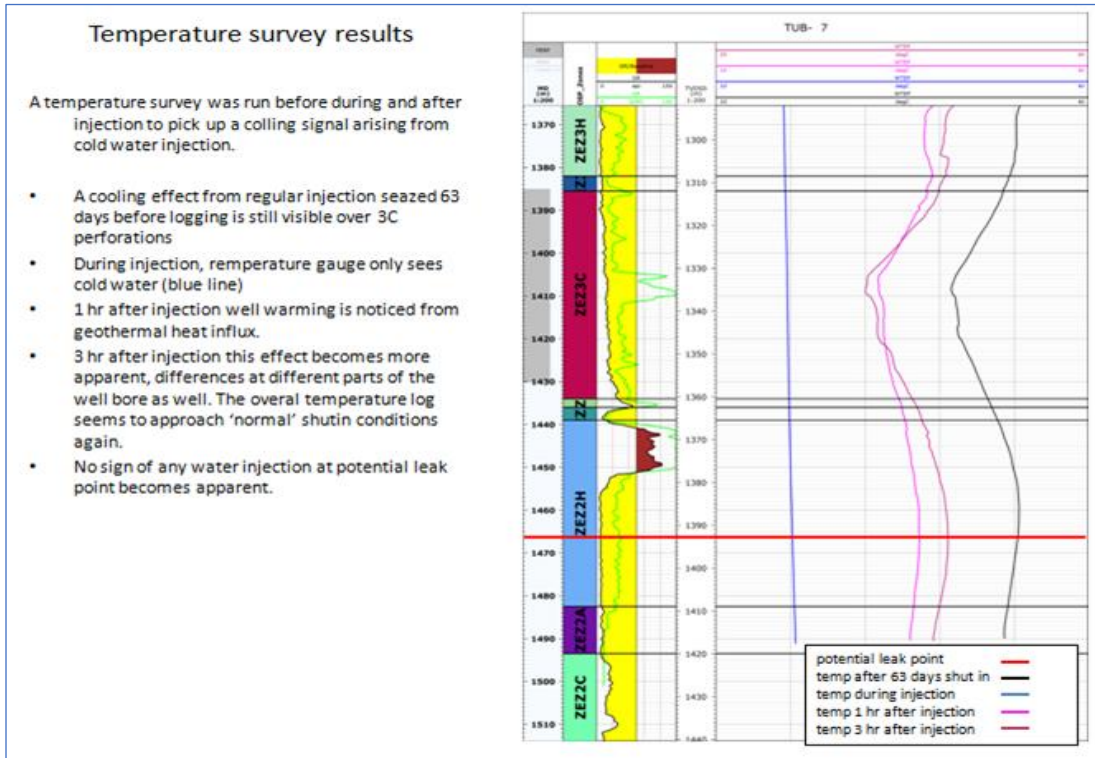
Figure B-4 –TUB-7 temperature logging results

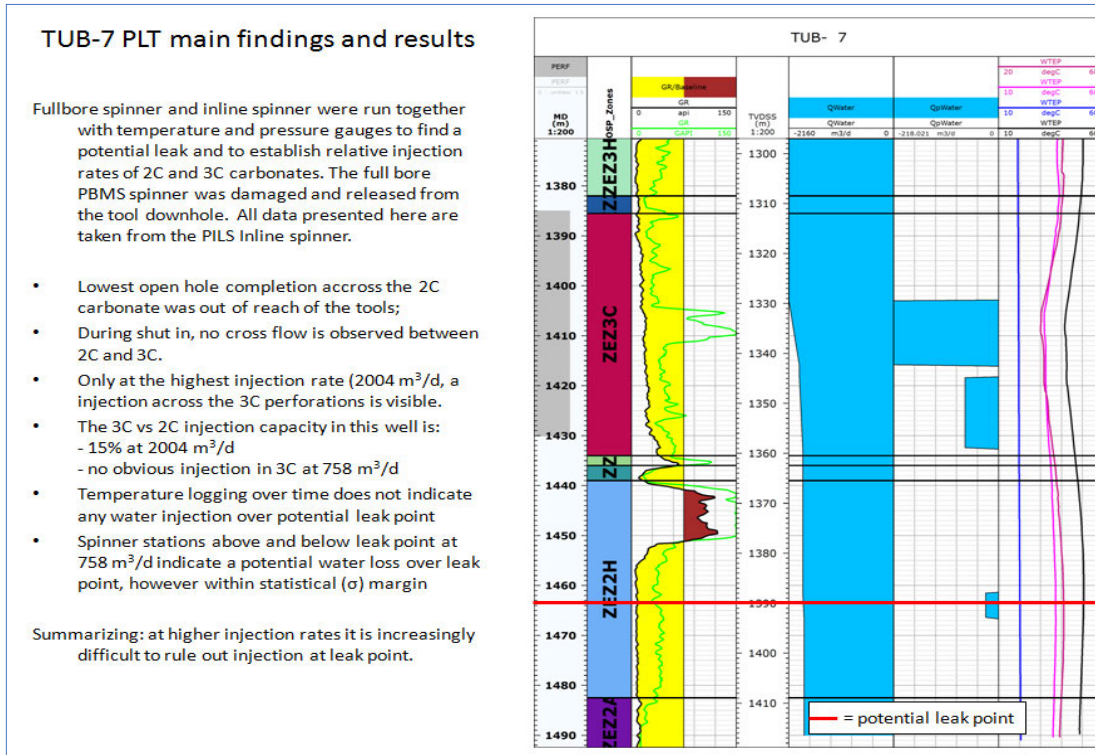
Figure B-5 – TUB-7 PLT results

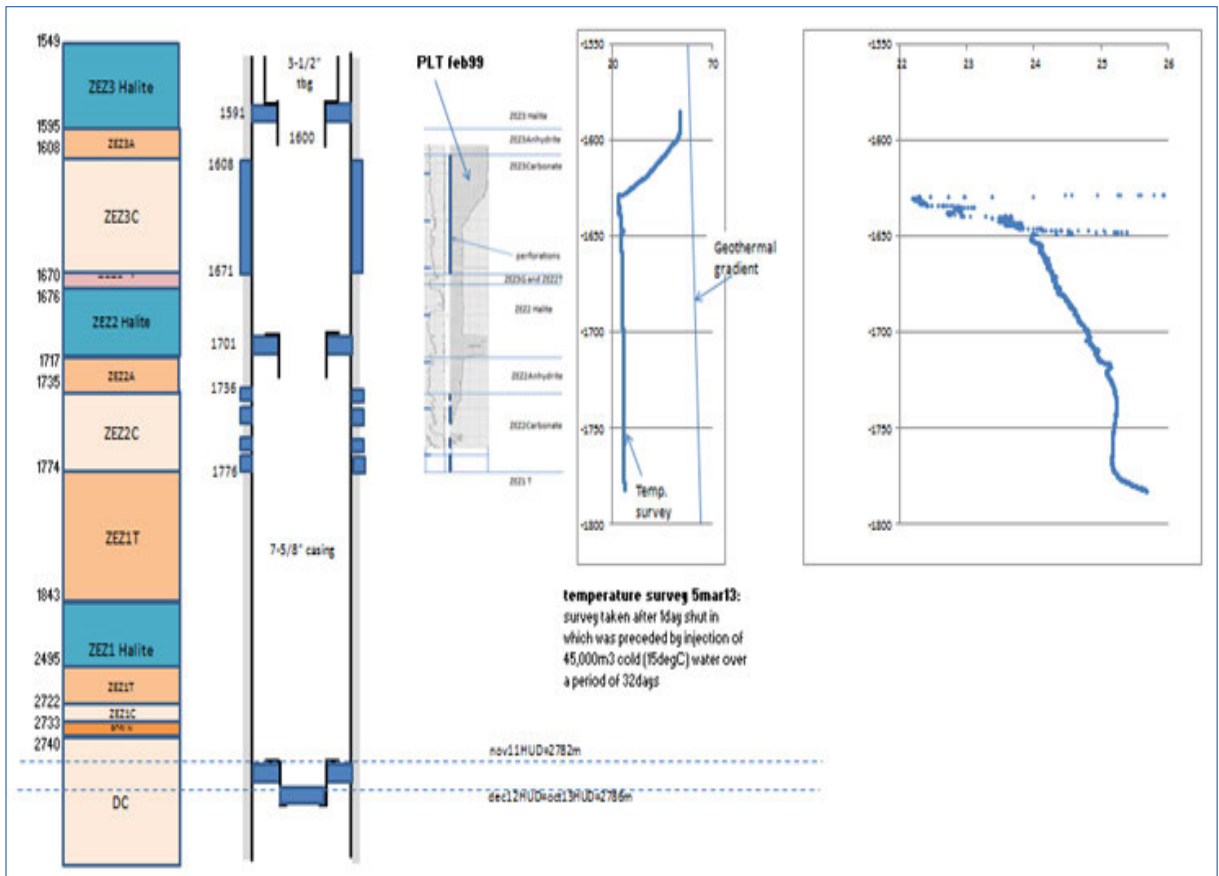
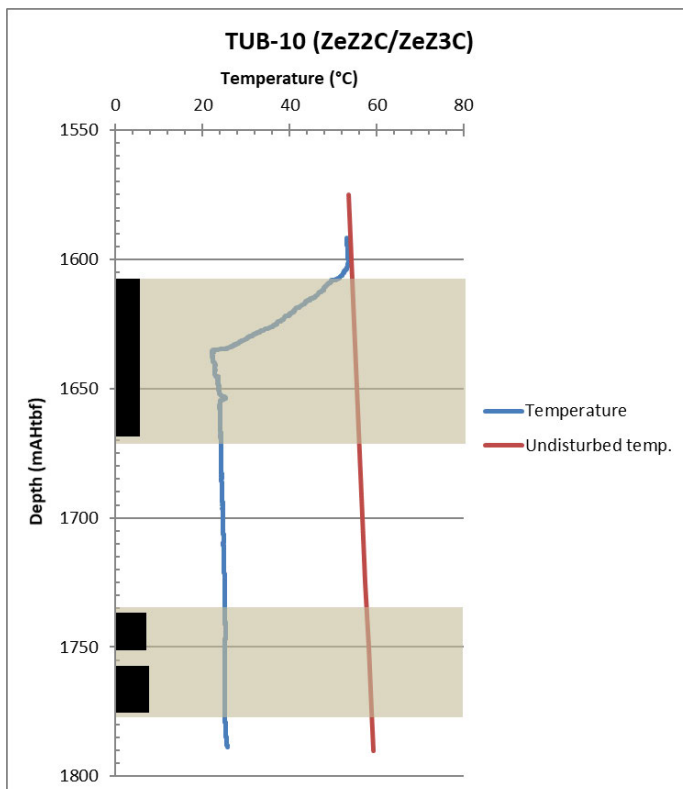
Figure B-6: TUB-10 temperature survey, December 2012
