Van: [redacted]@shell.com
Aan: SodM
Cc: [redacted]
Onderwerp: RE: Technische evaluatie Twente putten
Datum: vrijdag 8 januari 2021 14:49:31
Bijlagen: [6 yearly evaluation Twente water injection 2020 kenmerk EP202012203362.pdf](#)

Seismisch risicobeheersplan - Waterinjectie Twente velden

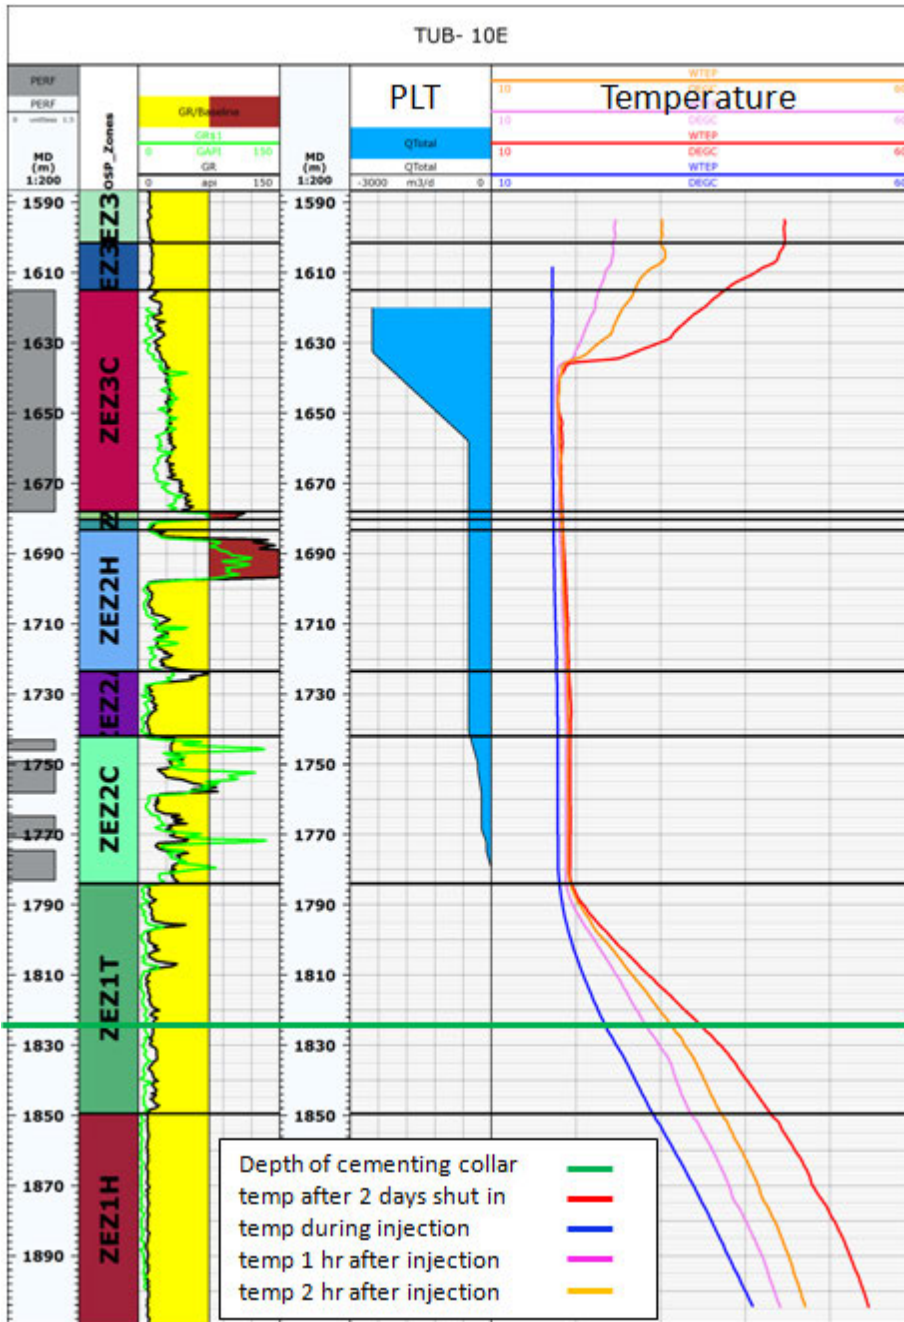
Figure B-7: TUB-10 PLT- and temperature survey, April 2015

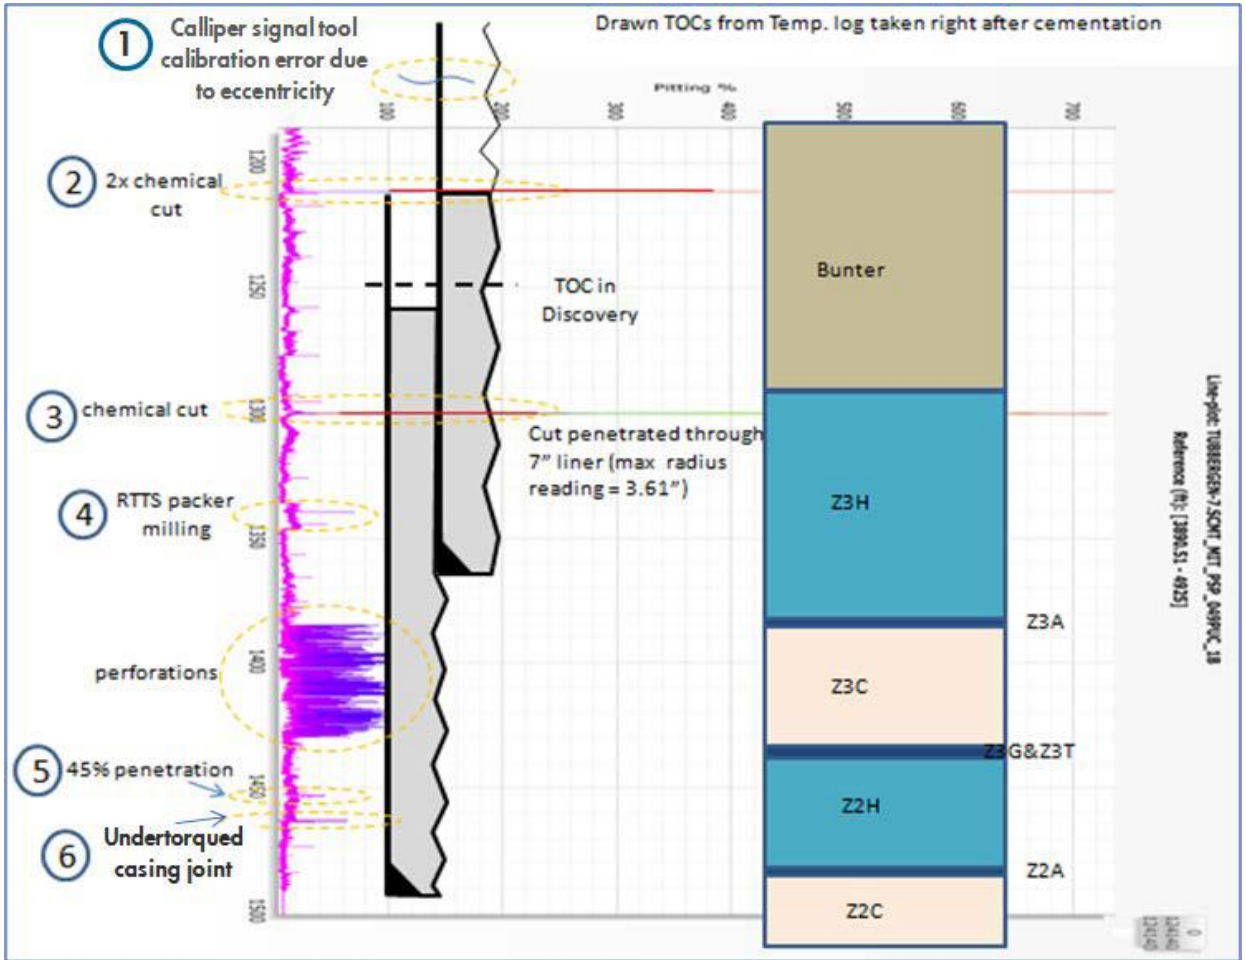
Figure C-1: PMIT-A caliper readings in TUB-7, Q4 2013

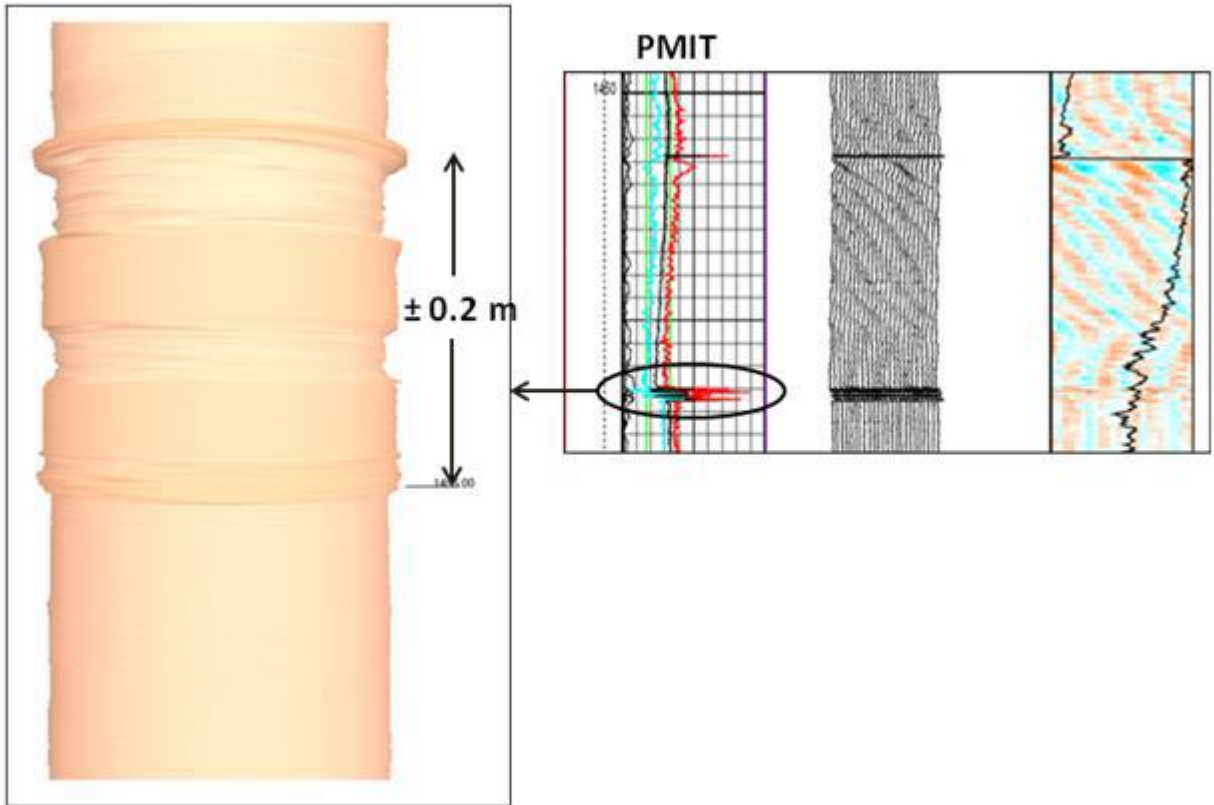
Figure C-2: 3D-caliper image of TUB-7 casing joint at 1464 mAHDF, Q4 2013.

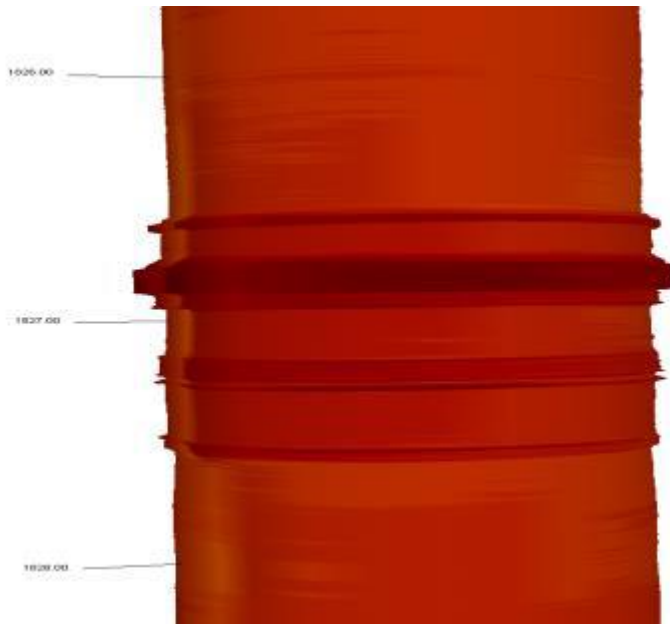
Figure C-3: 3D-caliper image of TUB-10 casing joint at 1827 mAHDF, Oct 2013.

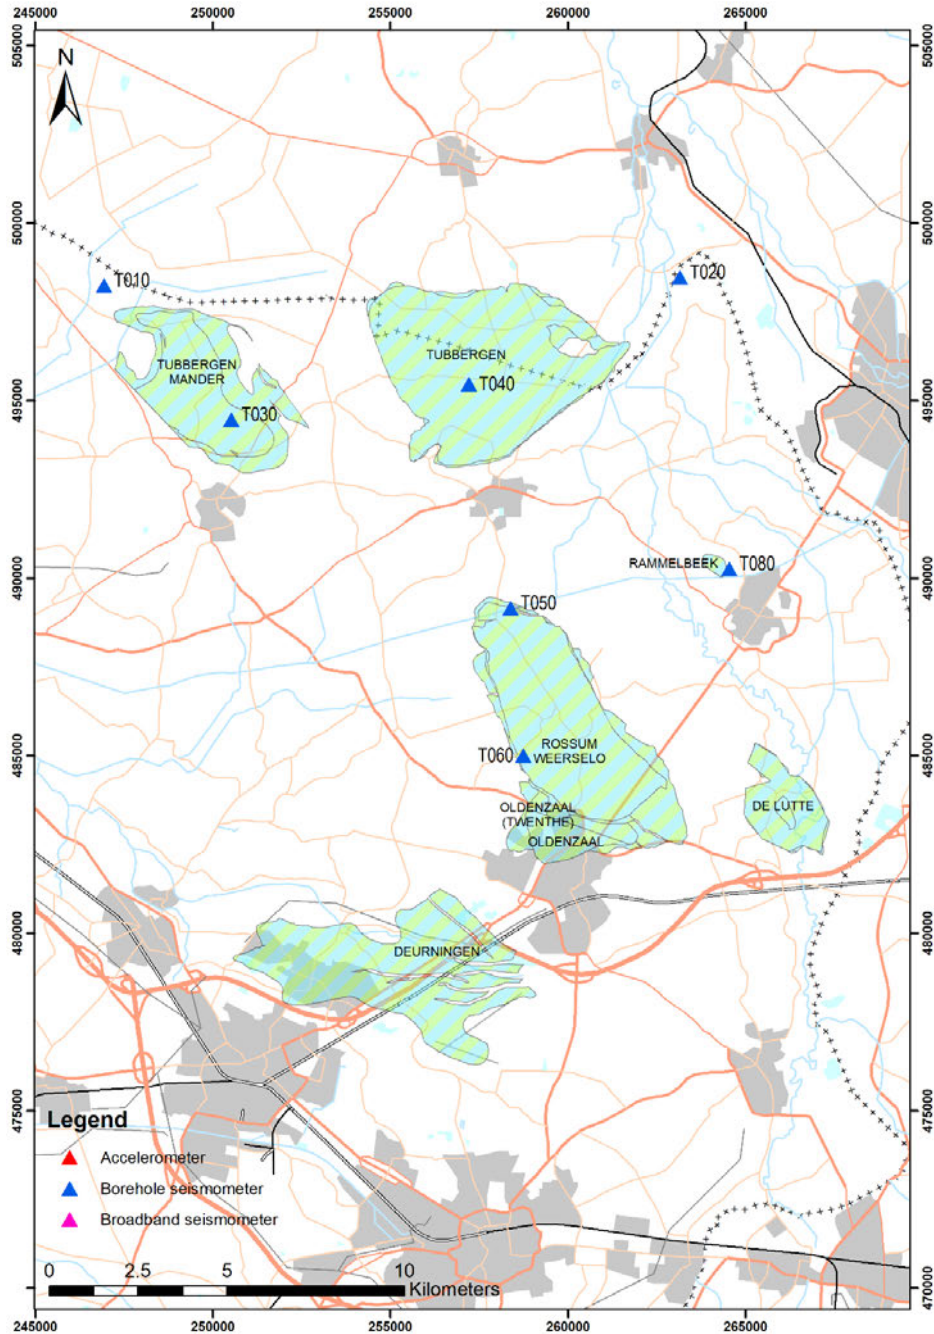
Figuur 1: Seismische stations in Twente.

geplaatst, met aan het maaiveld een accelerometer. Het netwerk maakt deel uit van het KNMI-netwerk en is in staat om aardbevingen groter dan $M=0,5$ te lokaliseren. Tot nu toe is er geen enkele aardbeving geregistreerd. De gegevens van dit netwerk zijn in te zien en op te vragen bij het KNMI.

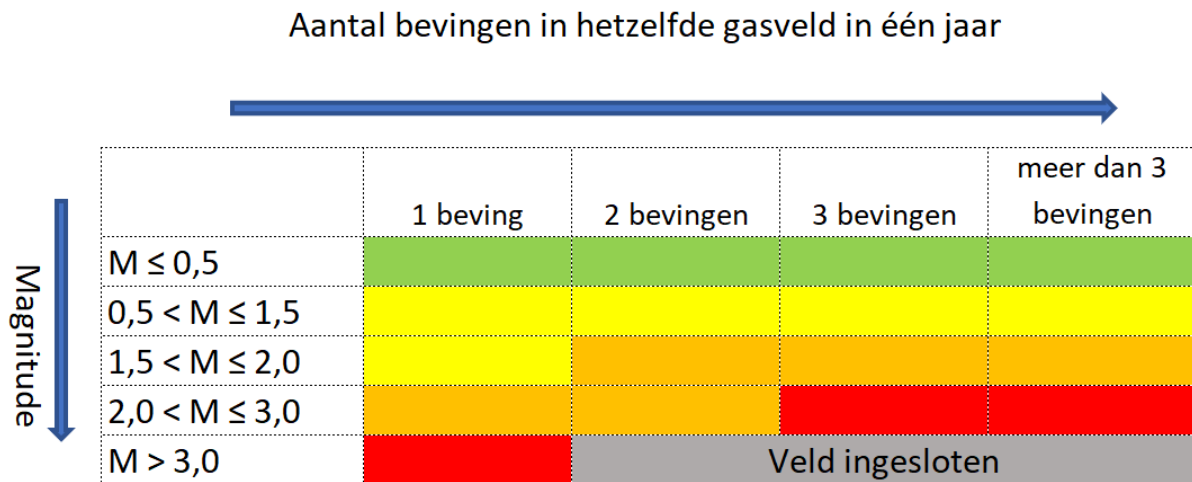
Figuur 2: Matrix behorend bij het seismische risicobeheerssysteem.

Een herhaling van bevingen kan zorgen voor een escalatie in het beheerssysteem volgens het schema in Figuur 2. Bijvoorbeeld, als er meer dan een beving is geweest met $M=1,8$ gedurende de laatste 12 maanden, zal het SRBT overgaan naar het escalatieniveau "oranje" (verhoogde seismische activiteit), met bijbehorende maatregelen. Een veld wordt ingesloten bij een beving van $M>3,0$ en gaat pas open na overleg met de toezichthouder (SodM) en communicatie met omgeving. Zodoende wordt de kans op meerdere bevingen met $M>3,0$ verder beperkt. Dit is aangegeven met het grijze vlak in Figuur 6.
